ROUTE NO.	SECTION	COUNTY	DATE	SHEET NO.	SHEET NO. 12
FAP 869	*	SALINE	44	23	17 SHEETS
FED. ROAD DIST. NO.	ILLINOIS	FED. AID PROJECT-			
98996					(105A)BR-1

**NORTH ABUTMENT
IL 34 OVER BANKSTON CREEK
FAP ROUTE 869 - SECTION (105A)BR-1
SALINE COUNTY
STATION 1582+30.00
STRUCTURE NO. 083-0040**

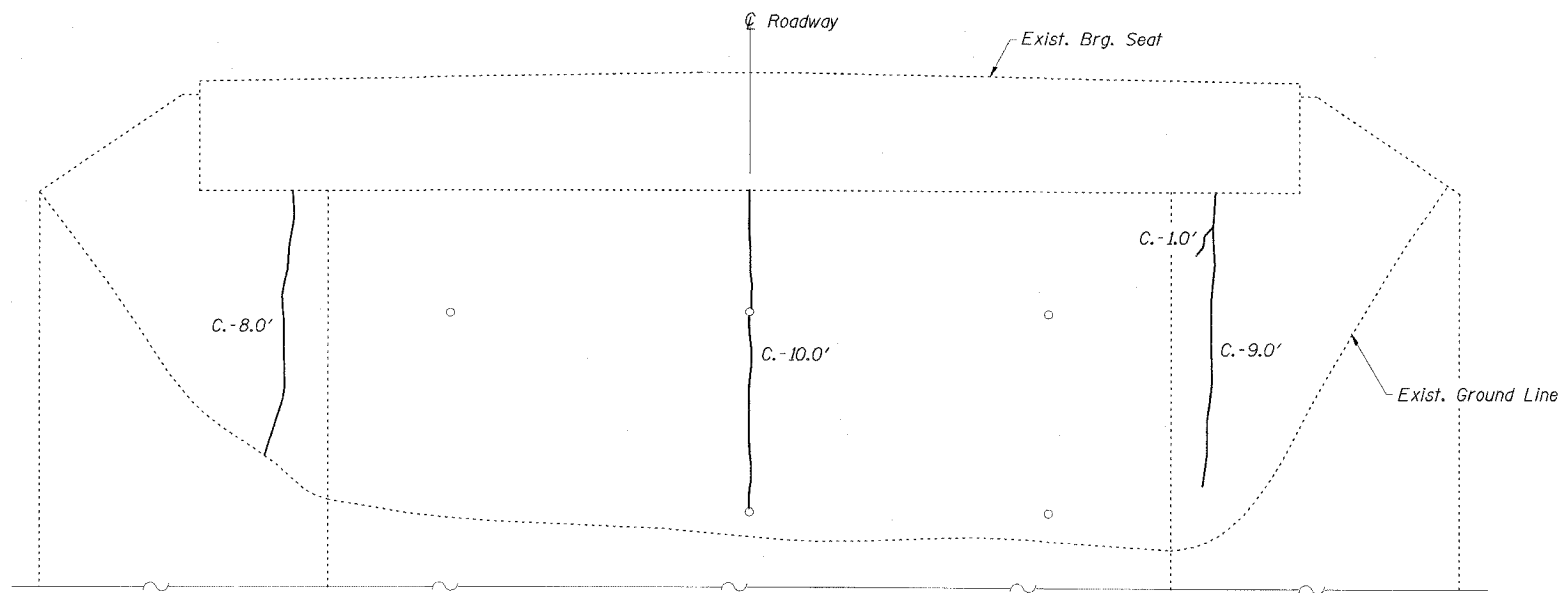
ELEVATION

NOTE: ABUTMENT CRACK REPAIR LENGTHS AND STRUCTURAL REPAIR OF CONCRETE AREAS ARE ESTIMATED FROM 12-14-06 SURVEY WORK. ACTUAL LOCATIONS AND QUANTITIES OF REPAIRS SHALL BE SHOWN BY THE ENGINEER ON THE AS-BUILT PLANS FOR THIS SECTION.

- C.-6' Crack to be epoxy injected
- S.F. Delaminated or Spalled Area - Use Structural Repair of Concrete
