STATE OF ILLINOIS
DEPARTMENT OF TRANSPORTATION

PIERS 41 AND 42 CONCRETE REPAIR DETAILS
STRUCTURE NO. 016-1026

SHEET NO. SF14 OF SF17 SHEETS

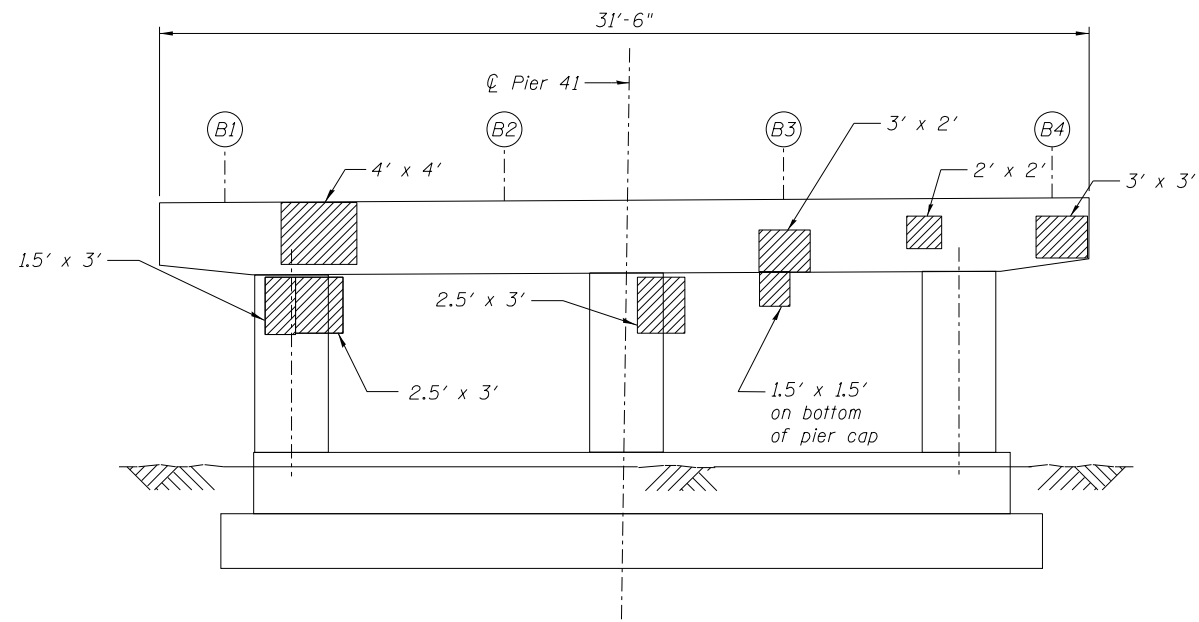
PIER 41
Looking East

Structural Repair of Concrete
(Depth Equal to or Less Than 5 Inches)

Hairline Crack (not to be repaired)
