STATE OF ILLINOIS
DEPARTMENT OF TRANSPORTATION

SUBSTRUCTURE REPAIRS
STRUCTURE NO. 082-0196

F.A.I. RTE. 64	SECTION 82-3HB	COUNTY ST. CLAIR	TOTAL SHEETS 208	SHEET NO. 207
CONTRACT NO. 76022				
FED. ROAD DIST. NO. 8 ILLINOIS FED. AID PROJECT

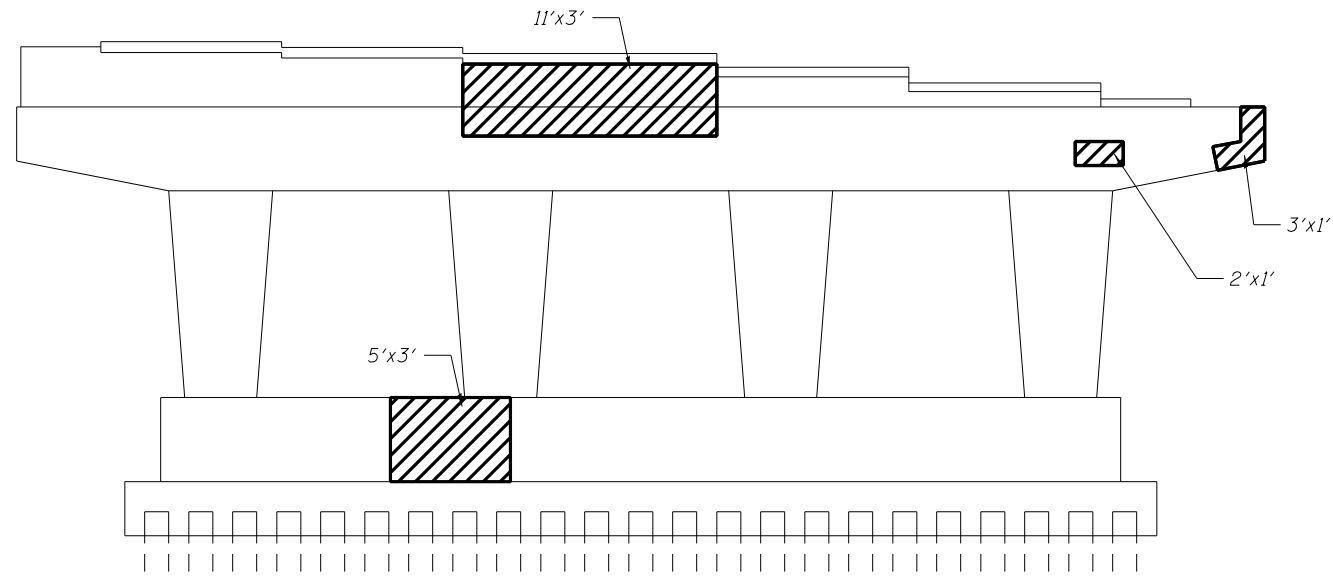
SOUTH PIER
(Looking South)

Area of Structural Concrete Repair
