Giorba Group, Inc.
CONSULTING ENGINEERS
3507 NORTH CUMBERLAND AVENUE :: CHICAGO, ILLINOIS 60656 :: (773) 775-4009

VILLAGE OF WINNETKA, ILLINOIS
PIER REPAIRS
ELDORADO STREET OVER THE UNION PACIFIC R.R.
R.R. MILE POST 17.26 KENOSHA SUBDIVISION
COOK COUNTY STA. 201+07.21
STRUCTURE NO. 016-8260

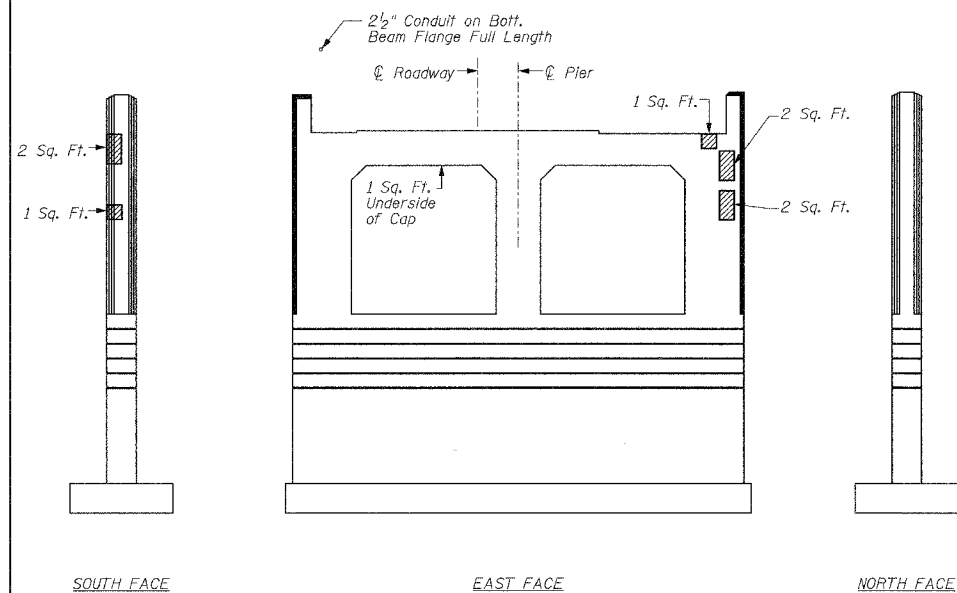
SOUTH FACE

EAST FACE

NORTH FACE
