**SUPERSTRUCTURE**  
**WEST BOUND LANES**

STRUCTURE NO. 081-0023 (W.B.)  
FAI ROUTE 280 Section D2 Br Wear Surf I-280  
Rock Island County  
Sta. 254+98.87

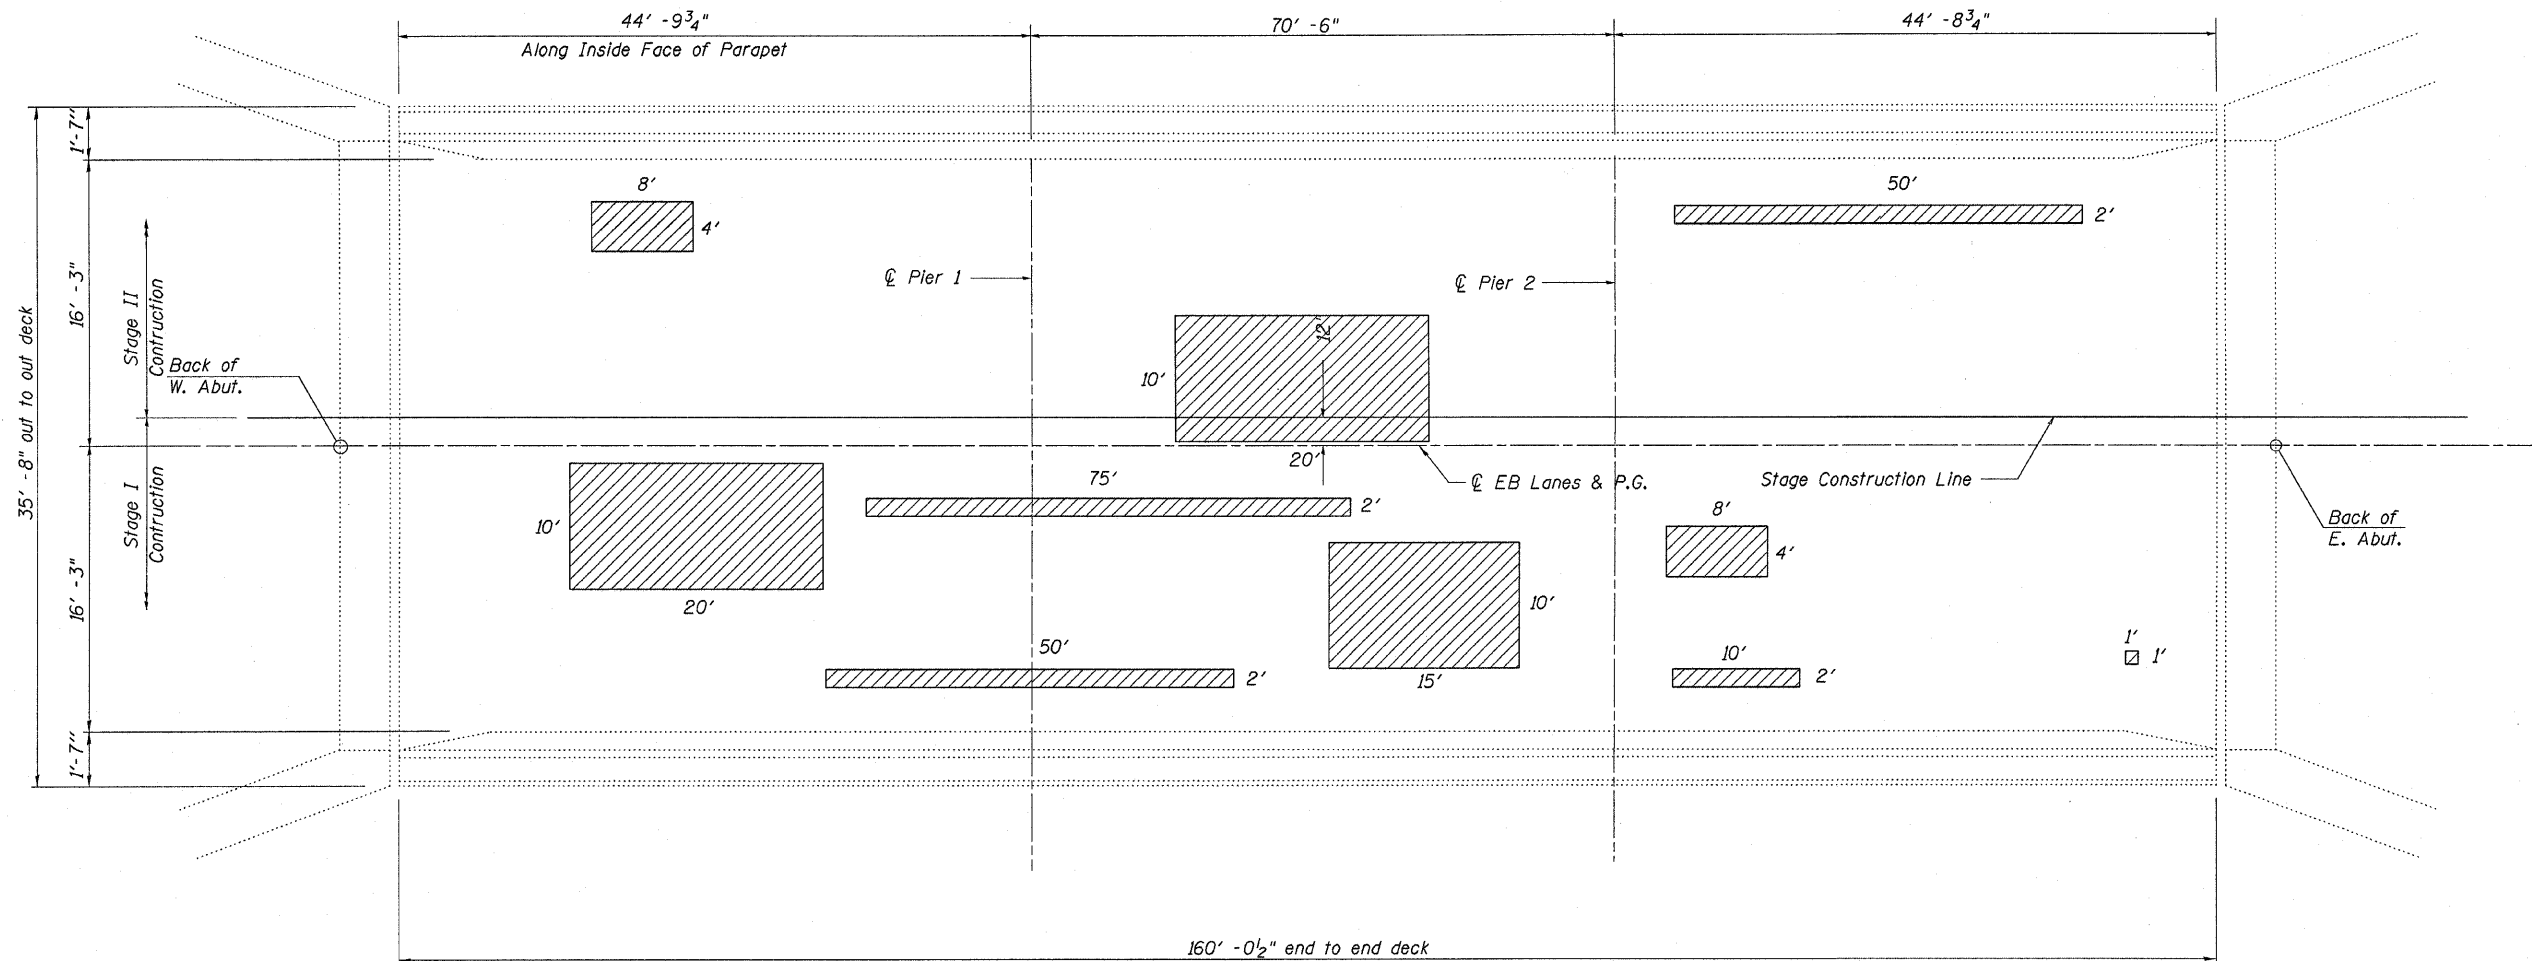
**PLAN**

Potential Deck Slab Repair (Partial)

Areas shown for repair are potential areas of deck slab repair. Actual locations and quantities to be determined in the field. Resident Engineer to contact District Bridge Office for assistance with locating patches.

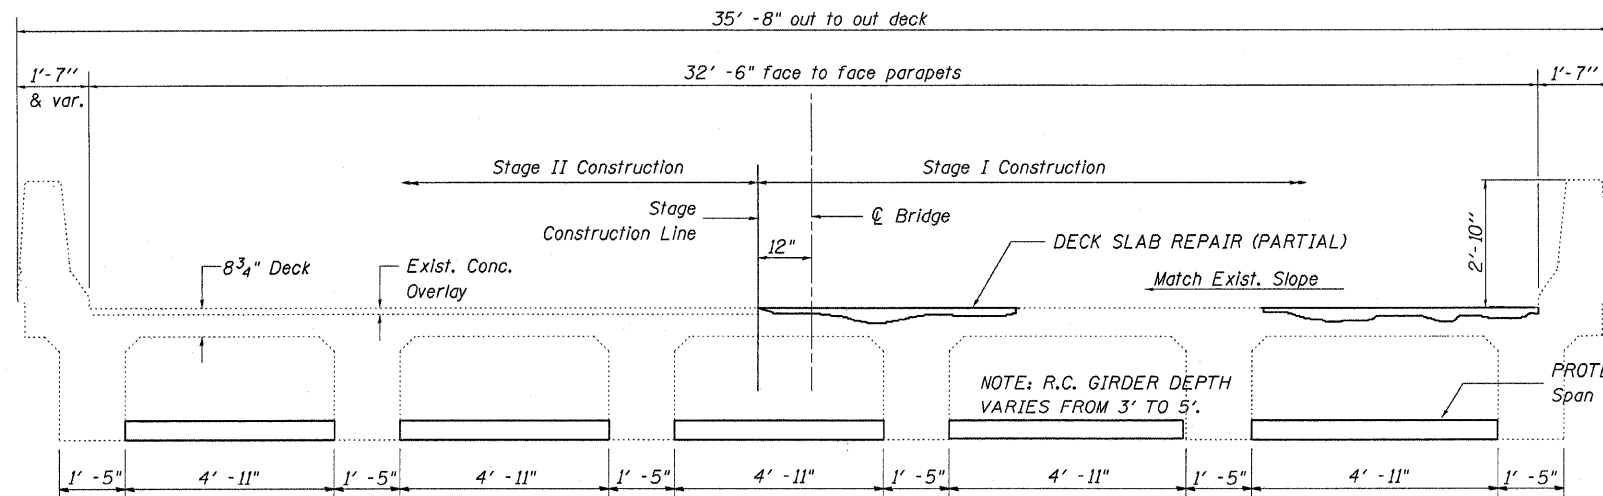
**CROSS SECTION**  
(Looking West)

Contractor is not allowed to drill into the stems of the T-girders in order to anchor the required Protective Shield system.
