SUPERSTRUCTURE
WEST BOUND LANES
 STRUCTURE NO. 081-0024 (W.B.)
 FAI ROUTE 280 Section D2 Br Wear Surf I-280
 Rock Island County
 Sta. 264+83.02

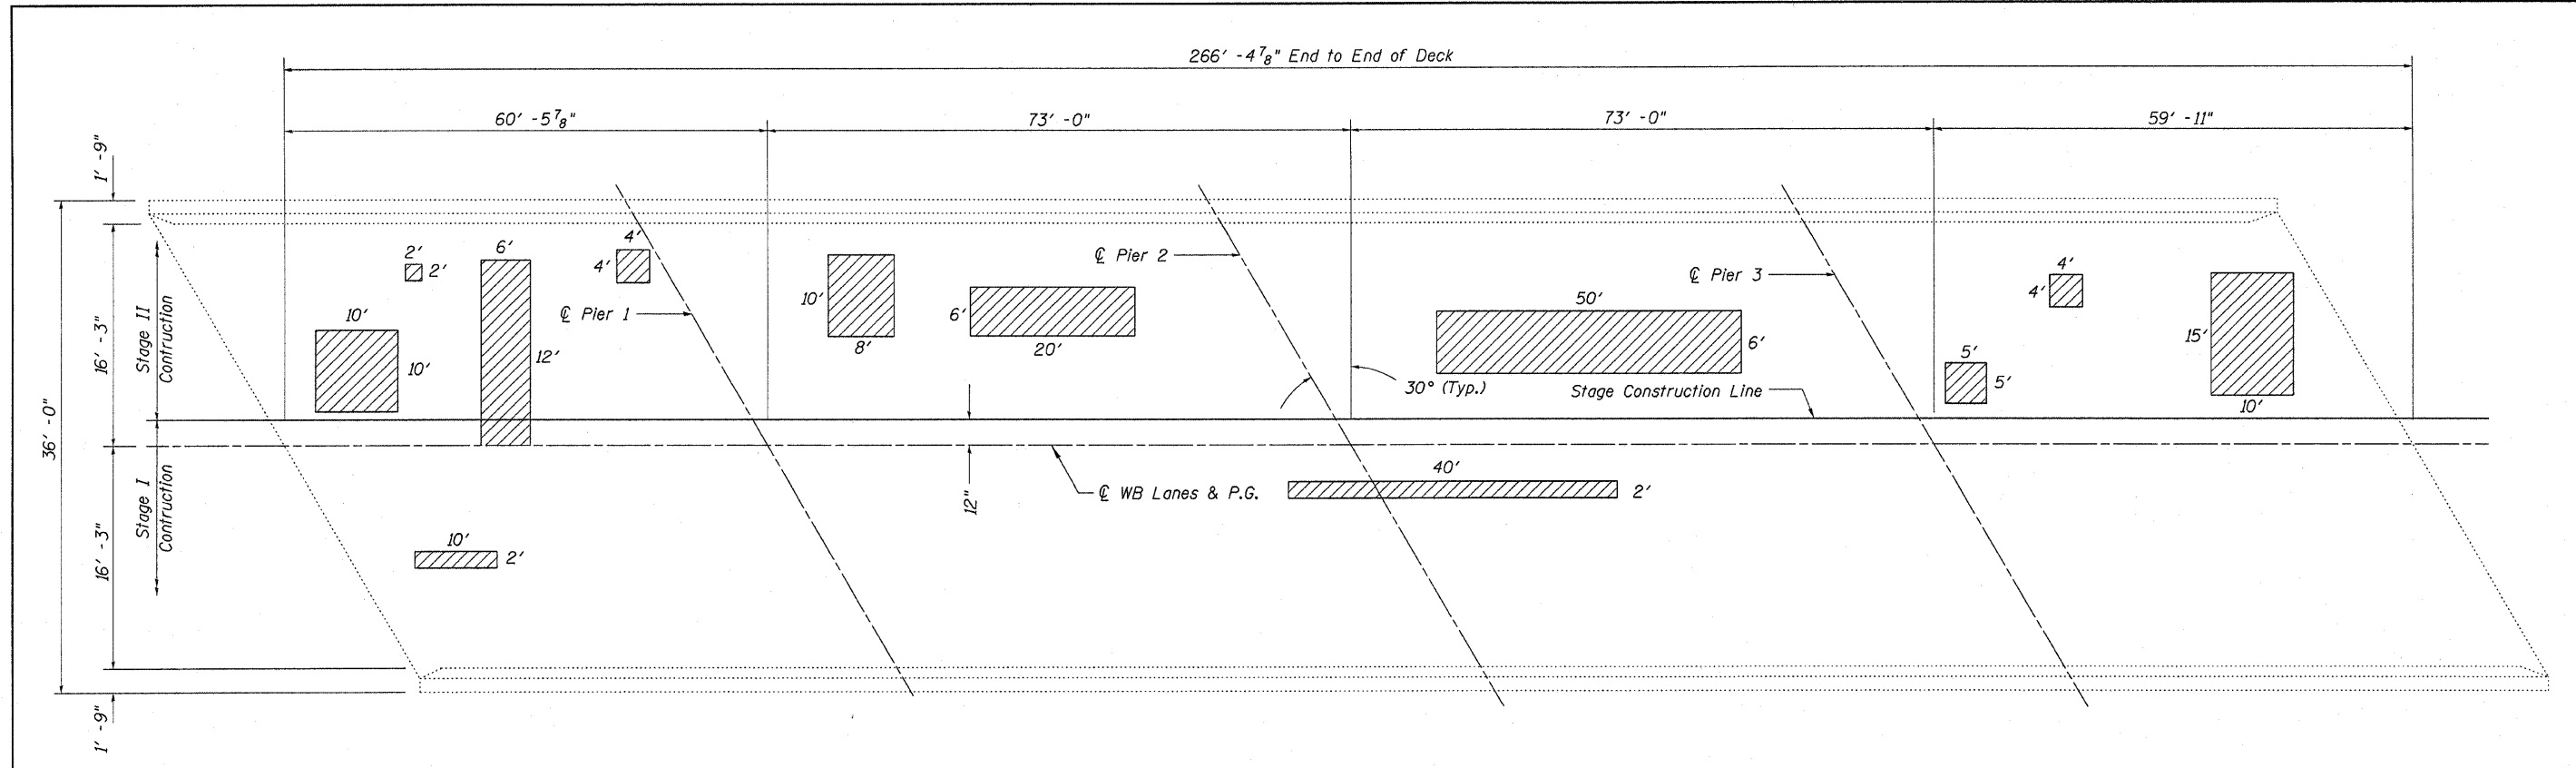
Legend
 Potential Deck Slab Repair (Partial)
 Date of Survey 10/2009

PLAN
 Areas shown for repair are potential areas of deck slab repair. Actual locations and quantities to be determined in the field. Resident Engineer to contact District Bridge Office for assistance with locating patches.
