SUPERSTRUCTURE
EAST BOUND LANES
STRUCTURE NO. 081-0025 (E.B.)
FAI ROUTE 280 Section D2 Br Wear Surf I-280
Rock Island County
Sta. 264+83.02

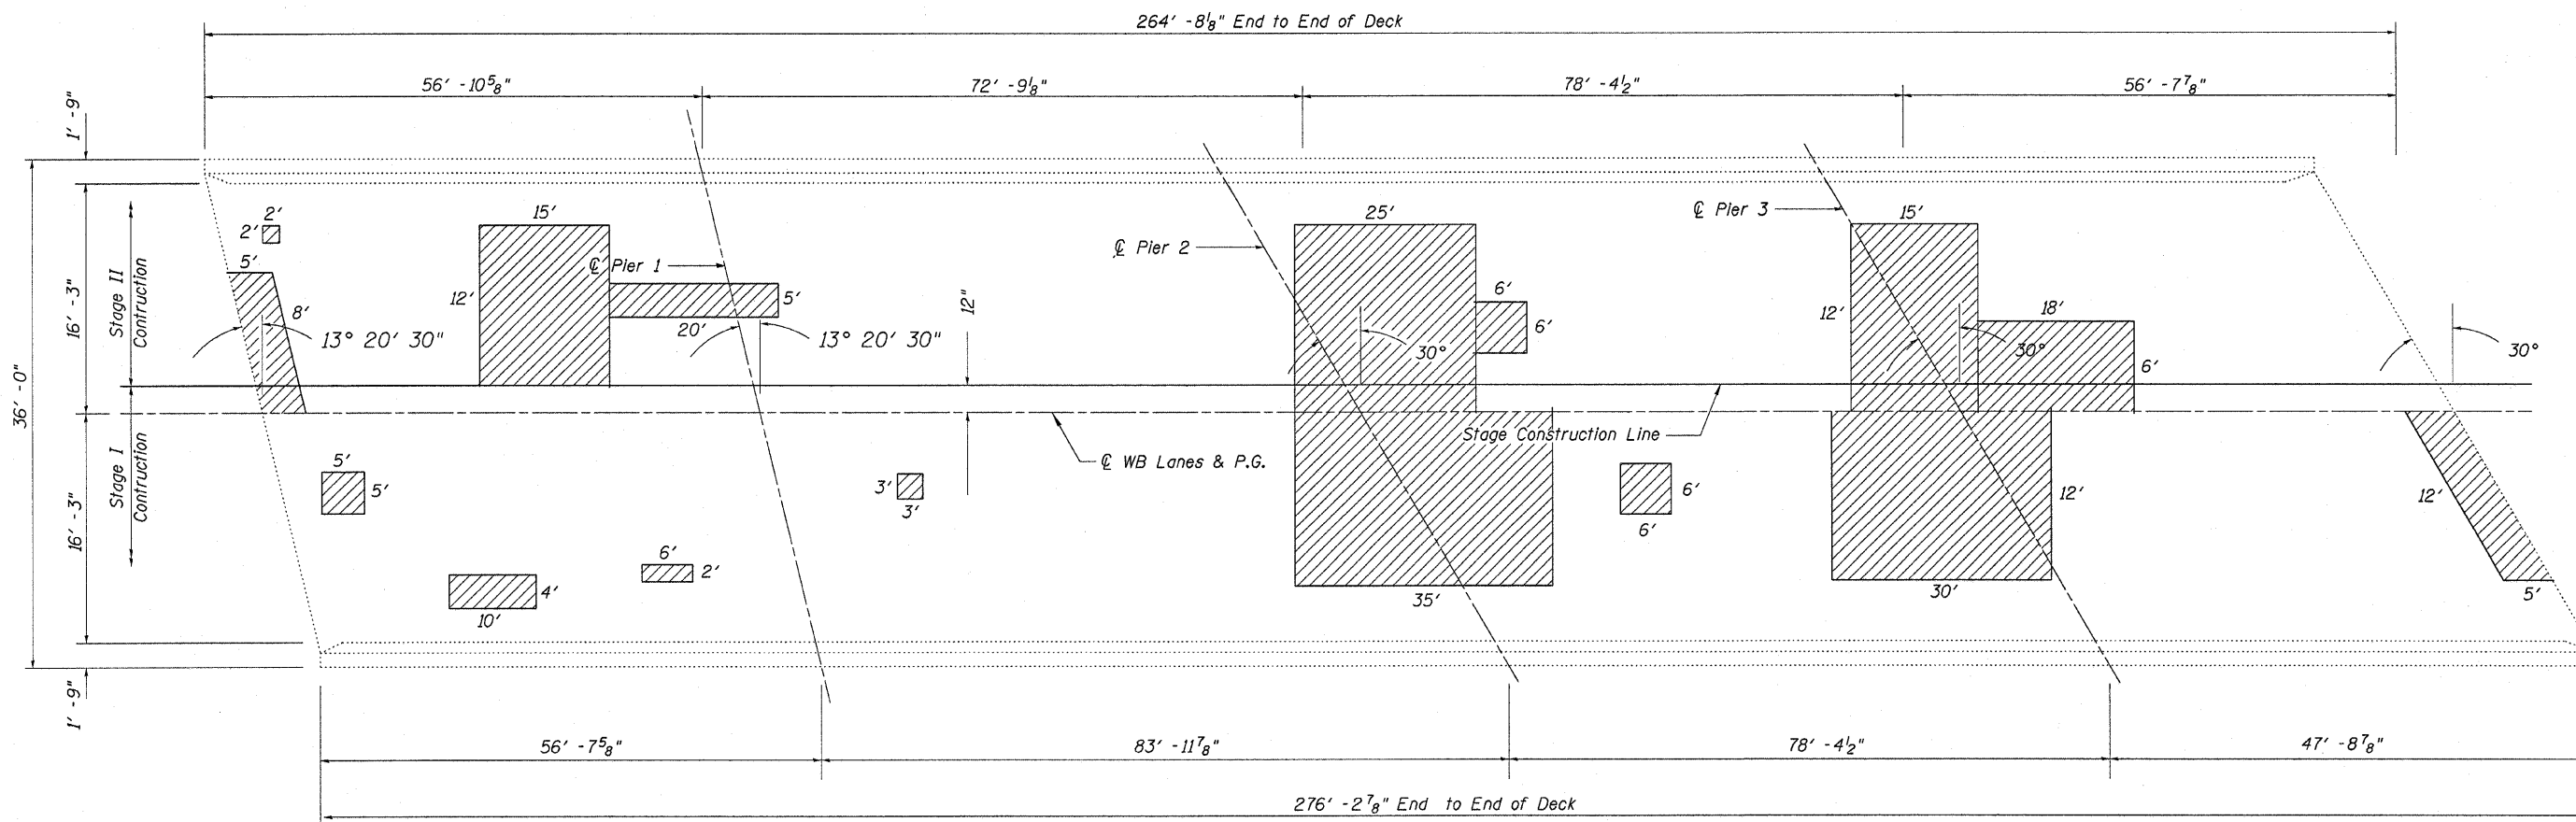
PLAN

Date of Survey 10/2009

Areas shown for repair are potential areas of deck slab repair. Actual locations and quantities to be determined in the field. Resident Engineer to contact District Bridge Office for assistance with locating patches.

DECK SLAB REPAIR (FULL DEPTH)	SQ YD	54
DECK SLAB REPAIR (PARTIAL)	SQ YD	219
