SUPERSTRUCTURE
EAST BOUND LANES
STRUCTURE NO. 081-0026 (E.B.)
FAI ROUTE 280 Section D2 Br Wear Surf I-280
Rock Island County
Sta. 286+90

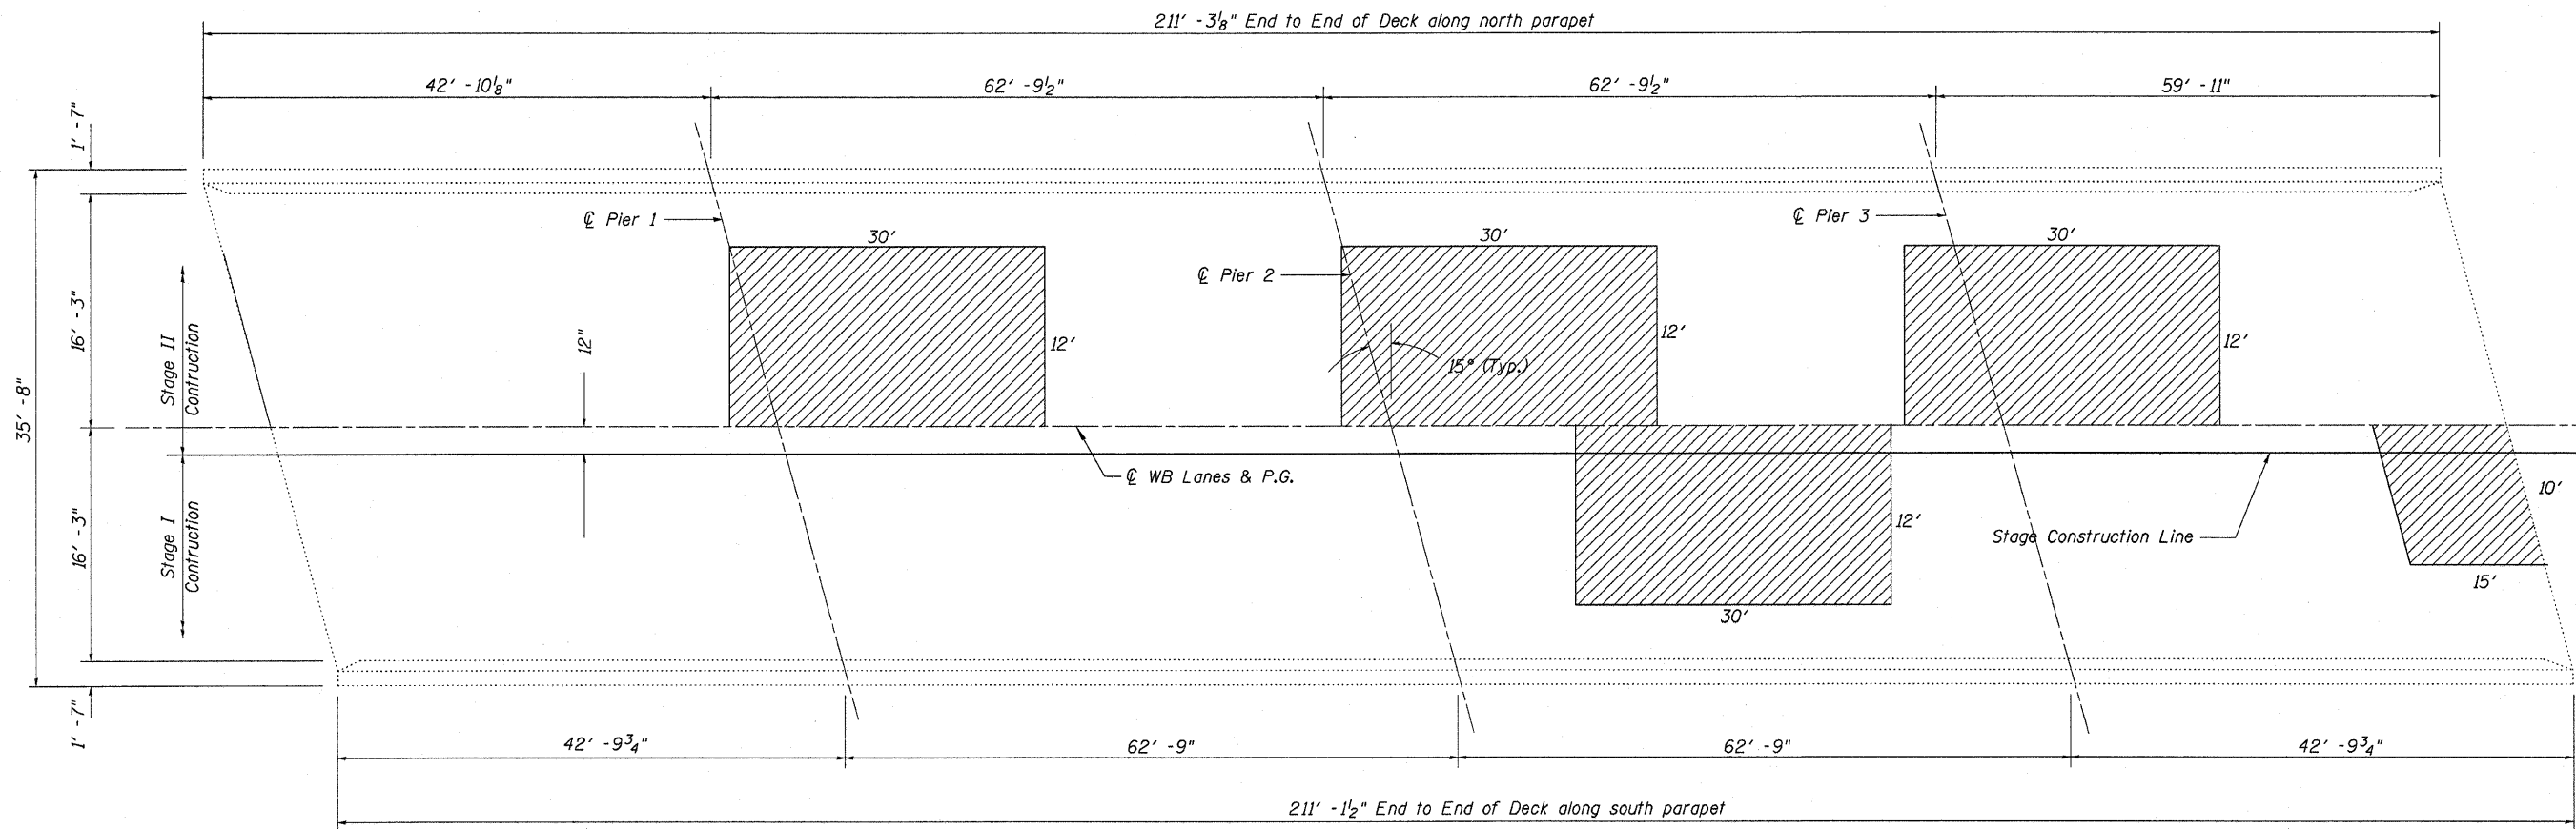
PLAN

Potential Deck Slab Repair (Partial)

Areas shown for repair are potential areas of deck slab repair. Actual locations and quantities to be determined in the field. Resident Engineer to contact District Bridge Office for assistance with locating patches.
