**SUPERSTRUCTURE**  
**WEST BOUND LANES**  
STRUCTURE NO. 081-0027 (W.B.)  
FAI ROUTE 280 Section D2 Br Wear Surf I-280  
Rock Island County  
Sta. 286+90

FILE NAME = G:\BRV\ADD plans\Rock Island County\2010	USER NAME = linkdj	DESIGNED -	REVISED -	<b>STATE OF ILLINOIS</b> <b>DEPARTMENT OF TRANSPORTATION</b>	<b>SUPERSTRUCTURE</b> <b>081-0027</b>	F.A.I. RTE. = 280	SECTION = *	COUNTY = ROCK ISLAND	TOTAL SHEETS = 19	SHEET NO. = 19
280 deck repair\PLANeng.dgn		DRAWN -	REVISED -			CONTRACT NO. 64F92				
PLOT SCALE = 58.0000' / IN.		CHECKED -	REVISED -			ILLINOIS FED. AID PROJECT				
PLOT DATE = Thu Nov 05 11:03:44 2009		DATE -	REVISED -

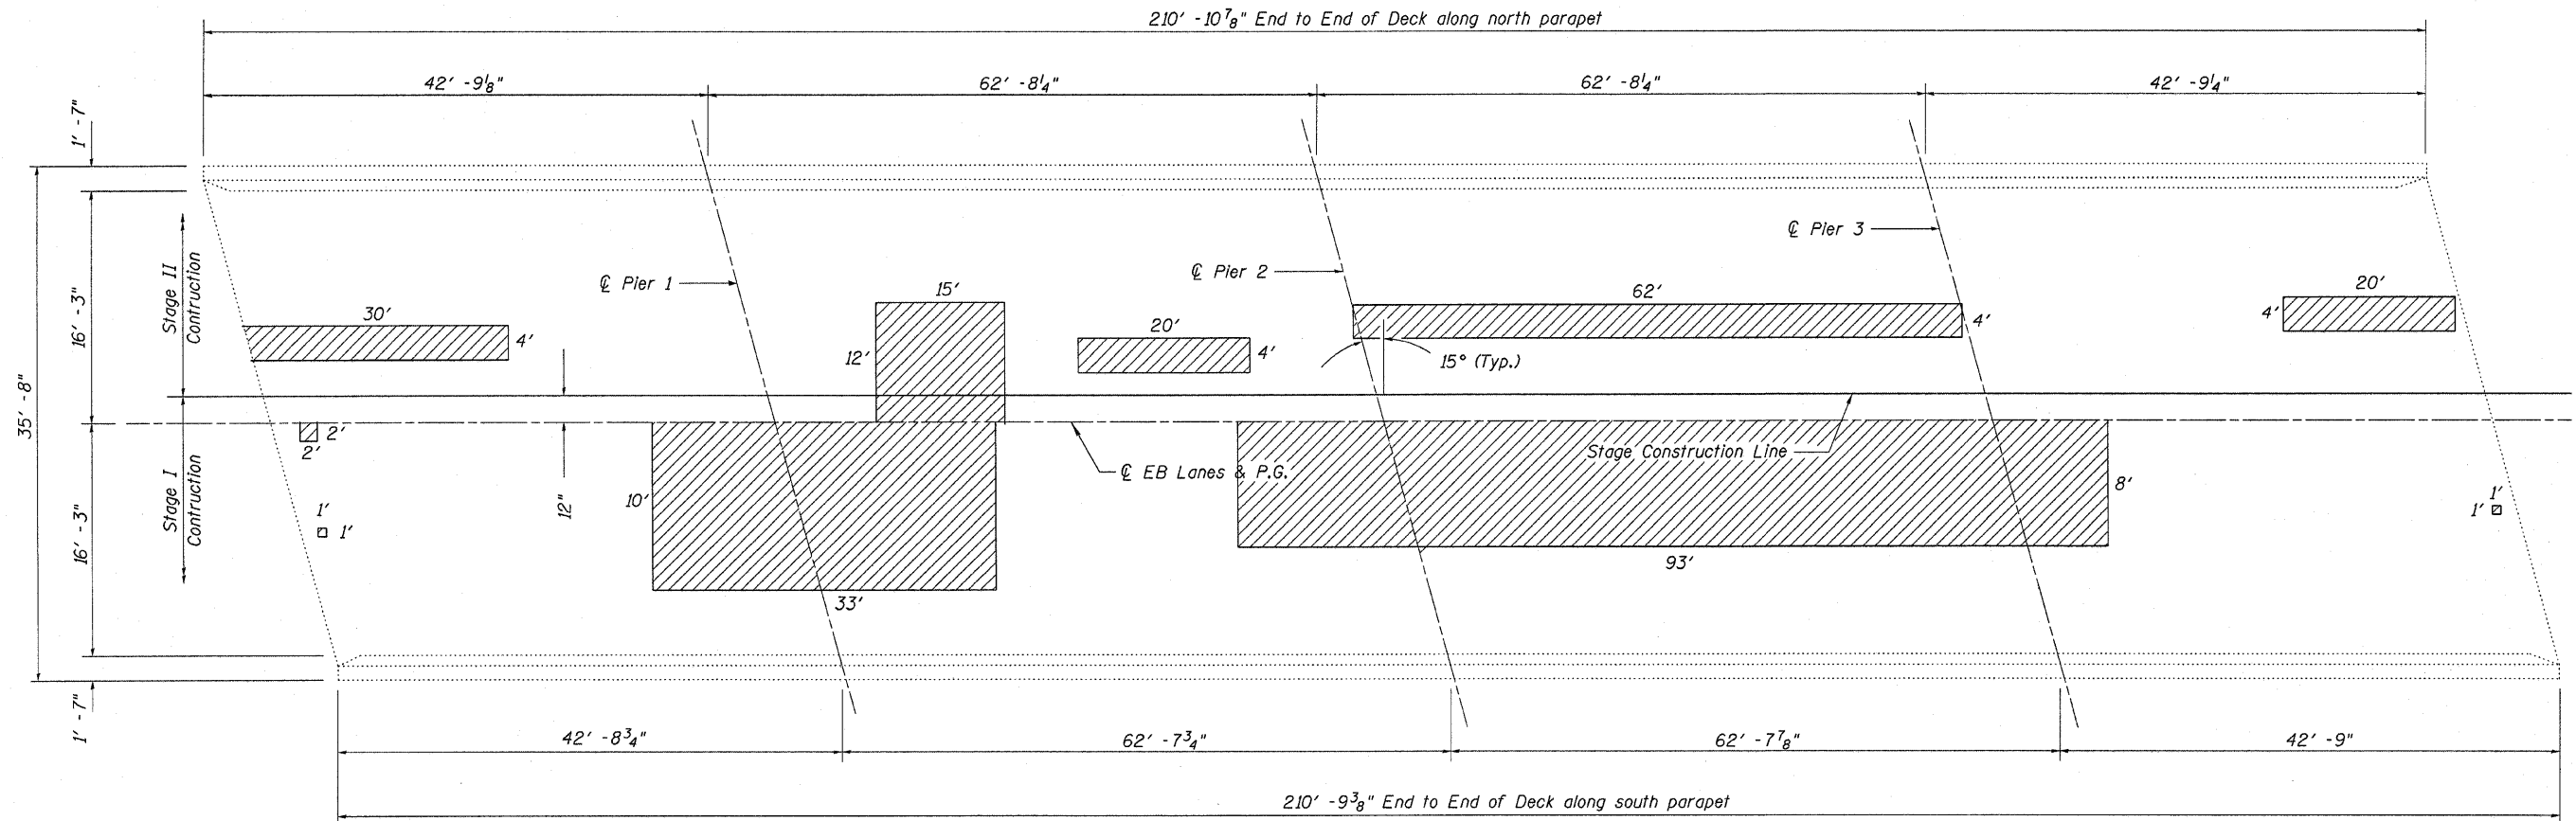
**PLAN**

Potential Deck Slab Repair (Partial)

Date of Survey 10/2009

Areas shown for repair are potential areas of deck slab repair. Actual locations and quantities to be determined in the field. Resident Engineer to contact District Bridge Office for assistance with locating patches.
