ILLINOIS DEPARTMENT OF TRANSPORTATION
CONCRETE REPAIR DETAILS
 OLD U.S. ROUTE 36 OVER
 SANGAMON RIVER
 F.A.U. ROUTE 797B
 SECTION BR-1
 SANGAMON COUNTY
 STA. 70+00.00
 STRUCTURE NUMBER 084-0052
 DATE: JAN. 2005
 DRAWN BY: NJV
 CHECKED BY: PBB

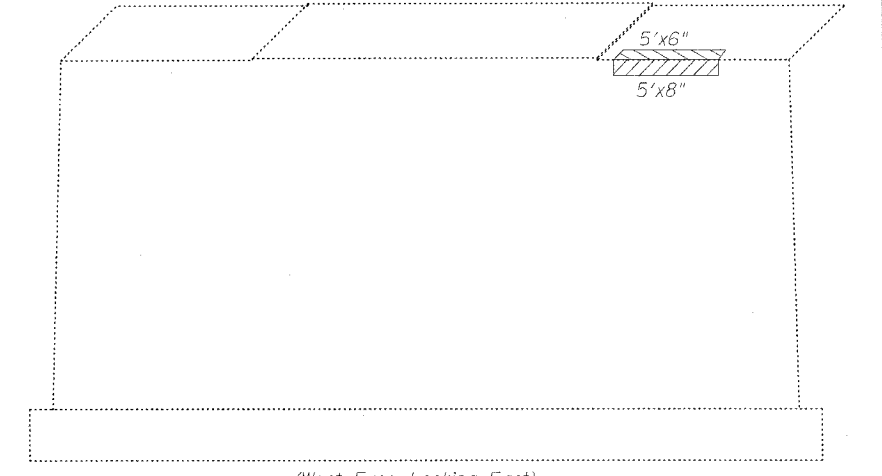
PIER 1 ELEVATION

Note: Pier 1 and Abutments do not have any repairs.
