**STATE OF ILLINOIS
 DEPARTMENT OF TRANSPORTATION**

**REPAIRS TO - PIER NUMBER 3 - COLUMNS
 STRUCTURE NO. 060-0255**

SHEET NO. 22 OF 48 SHEETS

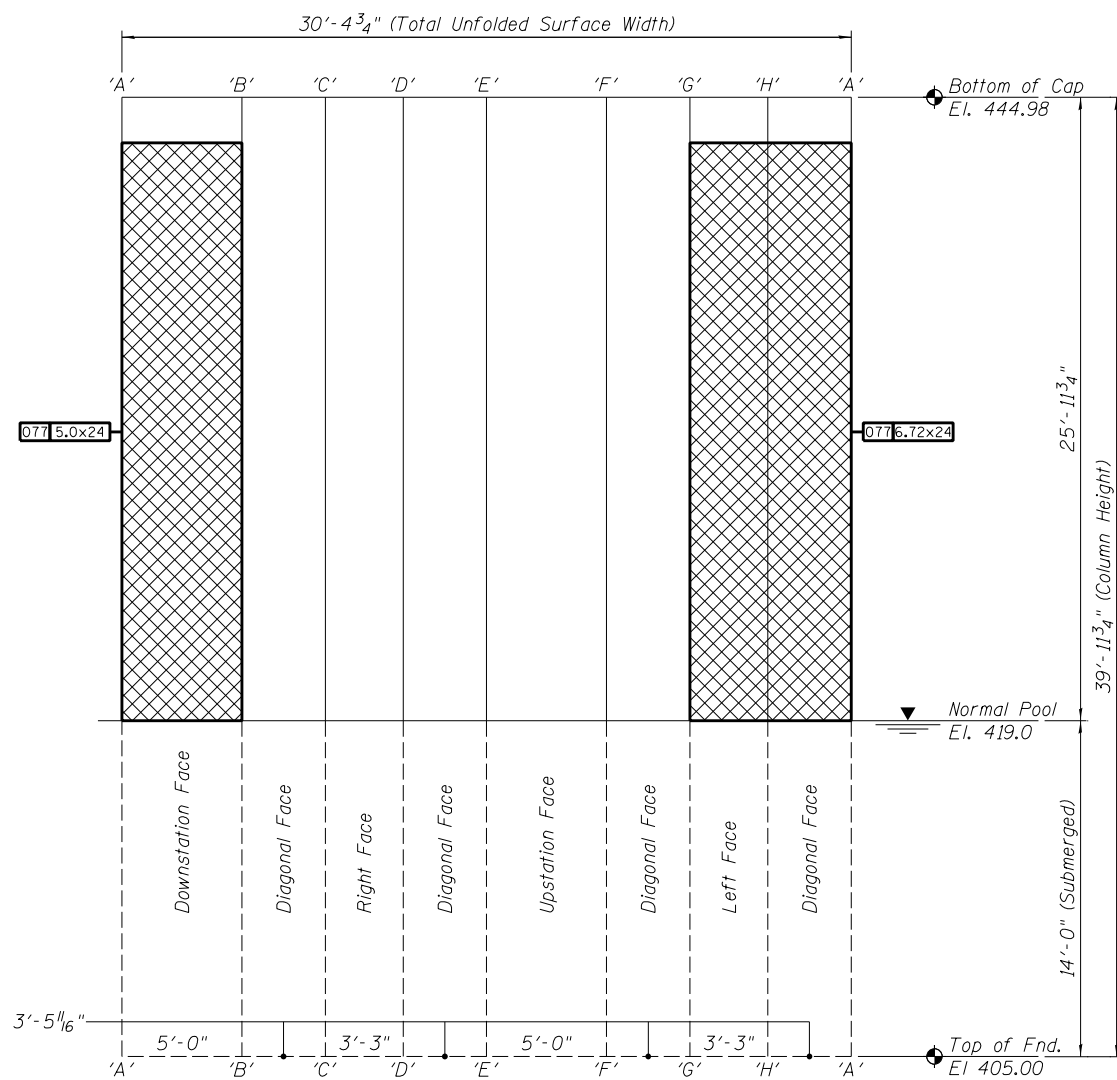
PIER NO. 3 - ELEVATION - LEFT COLUMN
 Column Surface Shown Unfolded

I.D.	Description	Pay Item	Units	Quantity
077	Map Cracking	Concrete Sealer	SQ. FT.	120.0
077	Map Cracking	Concrete Sealer	SQ. FT.	161.3
-	-	-	-	-
-	-	-	-	-
-	-	-	-	-
-	-	-	-	-
-	-	-	-	-
-	-	-	-	-
-	-	-	-	-

CONCRETE SEALER
