**STATE OF ILLINOIS
DEPARTMENT OF TRANSPORTATION**

**REPAIRS TO - PIER NUMBER 4 - COLUMNS
STRUCTURE NO. 060-0255**

SHEET NO. 24 OF 48 SHEETS

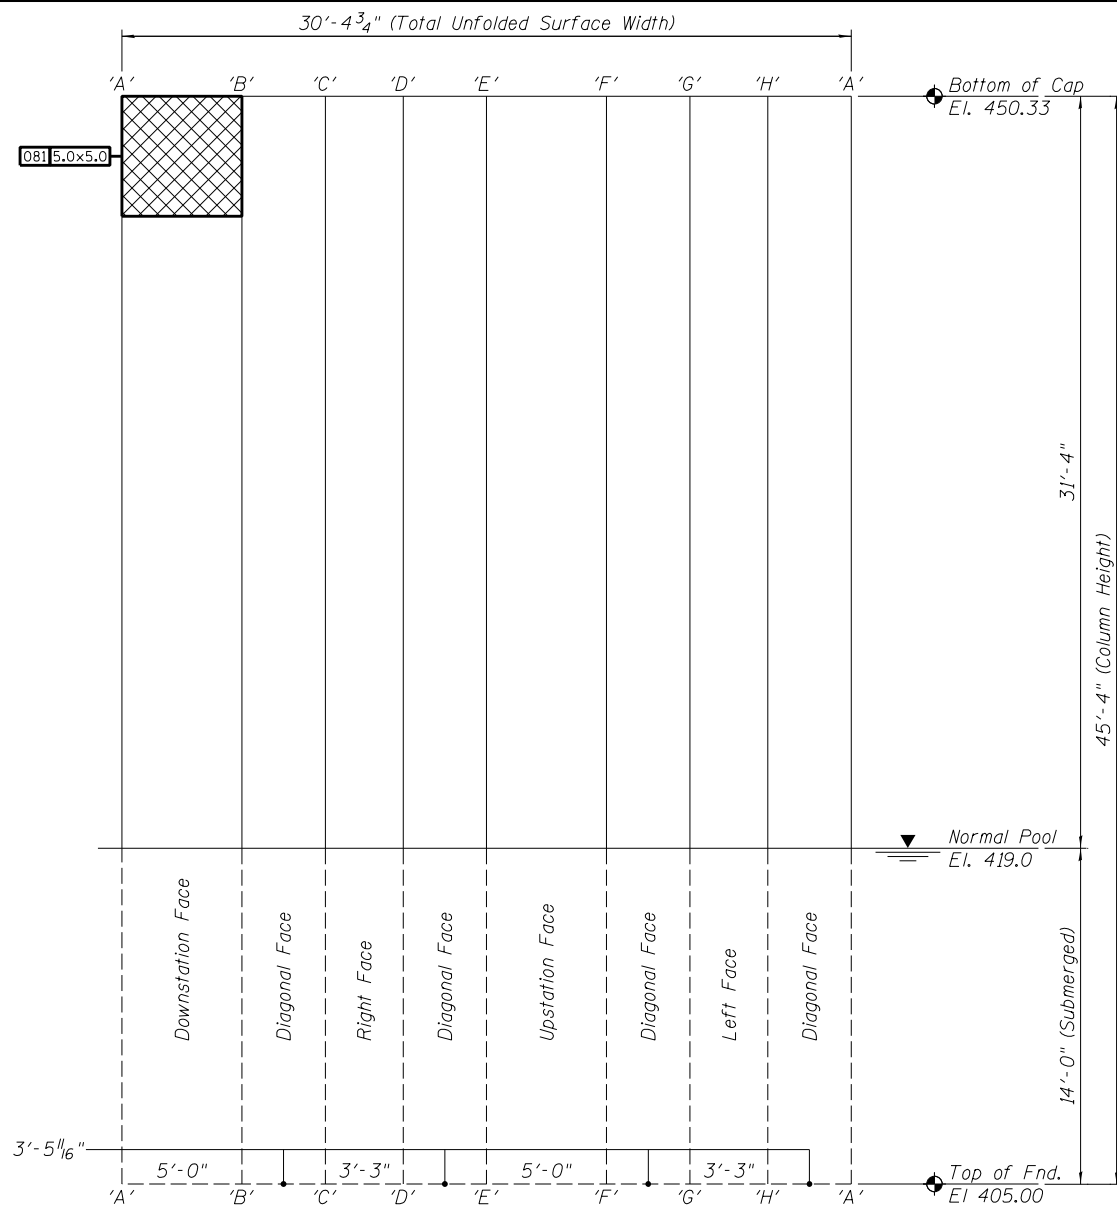
PIER NO. 4 - ELEVATION - LEFT COLUMN
Column Surface Shown Unfolded

I.D.	Description	Pay Item	Units	Quantity
081	Map Cracking	Concrete Sealer	SQ. FT.	25.0
-	-	-	-	-
-	-	-	-	-
-	-	-	-	-

CONCRETE SEALER
