**STATE OF ILLINOIS
 DEPARTMENT OF TRANSPORTATION**

**REPAIRS TO - PIER NUMBER 8 - COLUMN
 STRUCTURE NO. 060-0255**

SHEET NO. 29 OF 48 SHEETS

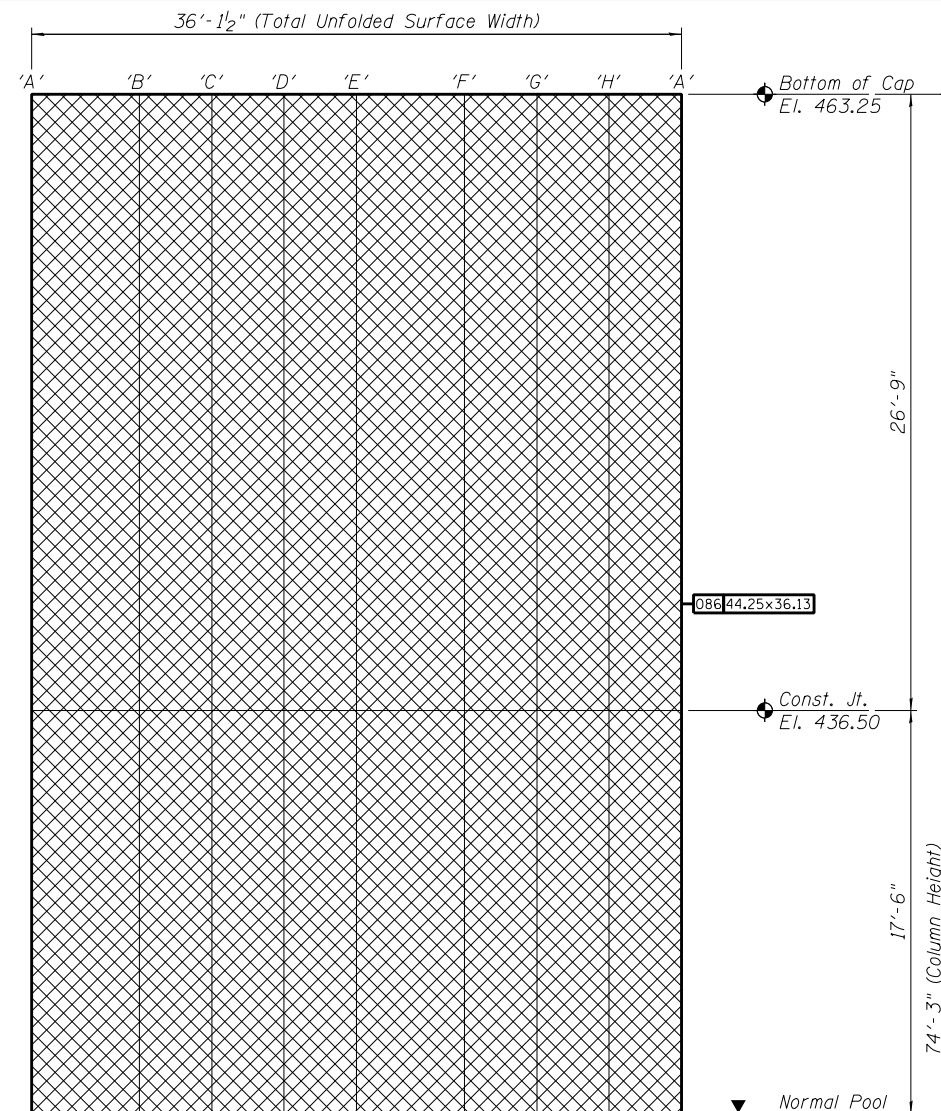
PIER NO. 8 - ELEVATION - LEFT COLUMN
 Column Surface Shown Unfolded

I.D.	Description	Pay Item	Units	Quantity
085	Map Cracking	Concrete Sealer	SQ. FT.	1598.8
086	Map Cracking	Concrete Sealer	SQ. FT.	1598.8
-	-	-	-	-
-	-	-	-	-
-	-	-	-	-
-	-	-	-	-
-	-	-	-	-
