**REPAIRS LIST - PIER 10 - PYLON HEAD**

**STATE OF ILLINOIS  
DEPARTMENT OF TRANSPORTATION**

**REPAIRS TO - ILLINOIS PYLON (PIER 10) - HEAD & ACCESS SPACES  
STRUCTURE NO. 060-0255**

SHEET NO. 35 OF 48 SHEETS

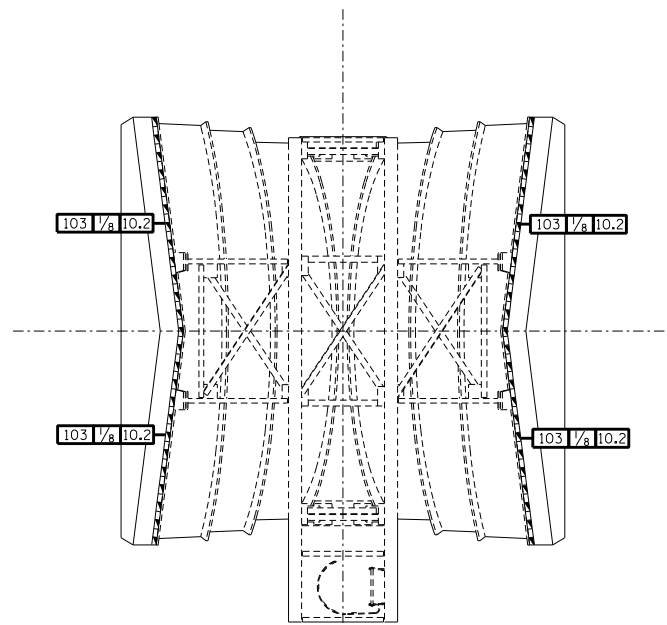
**PLAN - STAY SADDLES**

I.D.	Description	Pay Item	Units	Quantity
103	Failed Sealant Btwn. Saddle Stl. & Conc.	Polyurethane Sealant	FOOT	40.8
-	-	-	-	-
-	-	-	-	-
-	-	-	-	-
-	-	-	-	-

**POLYURETHANE SEALANT**

Note:  
 Sealant shall be Non-staining gray one component non-sag elastomeric gun grade polyurethane sealant meeting the requirements of ASTM C-920, Type S, Grade NS, Class 25.
