PIER 3

PIER 4

DESIGNED - JC	REVISED -		STATE OF ILLINOIS DEPARTMENT OF TRANSPORTATION		PIER REPAIR DETAILS EASTBOUND FAI-80 OVER DES PLAINES RIVER STRUCTURE NO. 099-0056		F-A.J. RTE.	SECTION	COUNTY	TOTAL SHEETS	SHEET NO.
USER NAME = truelle	DRAWN - JC						80	99(2&3)RS-3	WILL	200	131
PLOT SCALE = NTS	CHECKED - DF						CONTRACT NO. 60M64				
PLOT DATE = 1/20/2011 12:56:05 PM	DATE - 01/21/2011						FED. ROAD DIST. NO. [ILLINOIS] FED. AID PROJECT

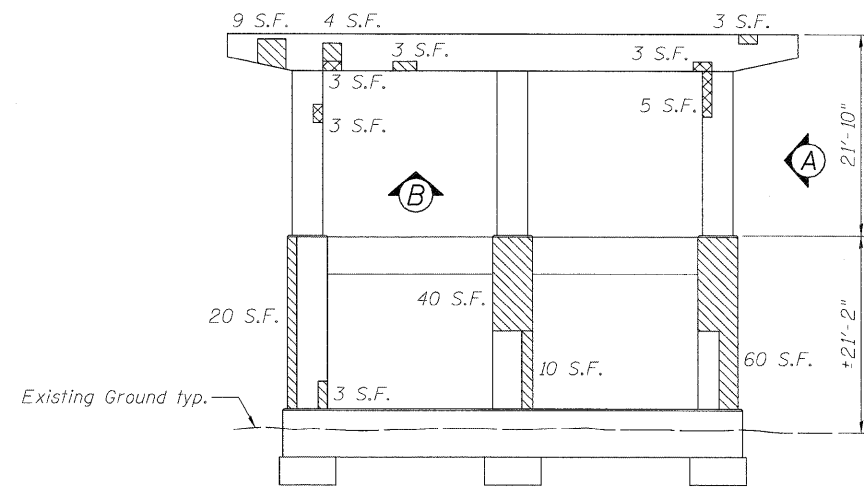
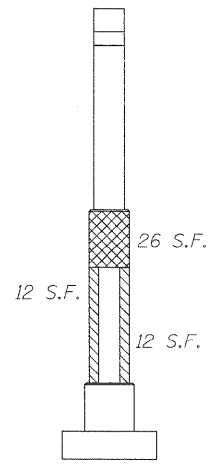
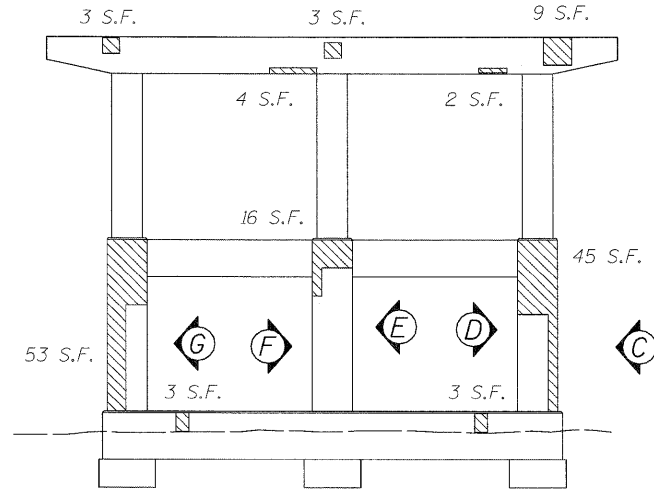
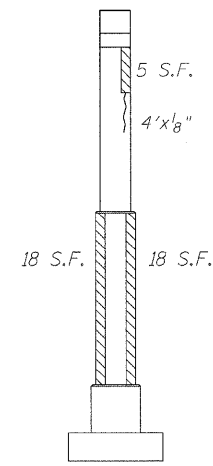
- Structural Repair of Concrete (Depth < 5") = 408 Sq. Ft.
- Structural Repair of Concrete (Depth > 5") = 58 Sq. Ft.
- Epoxy Crack Injection

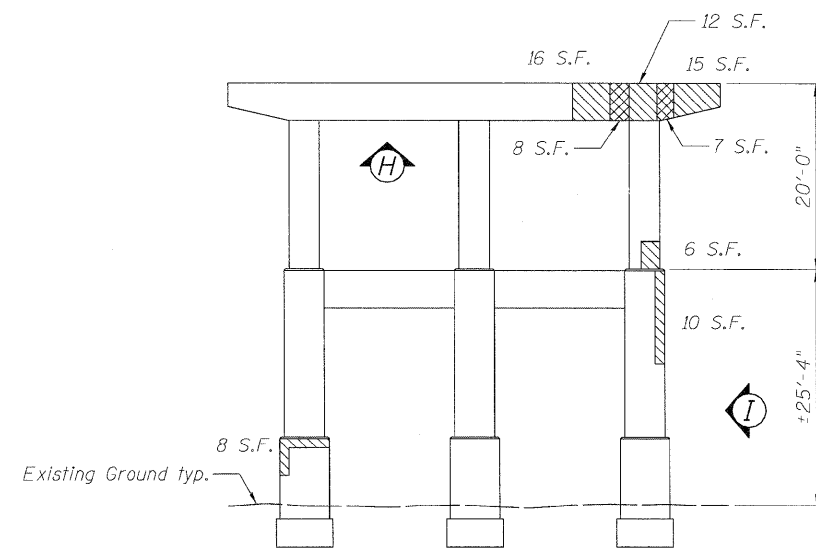
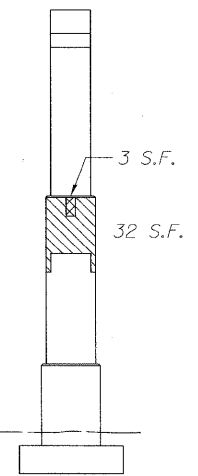
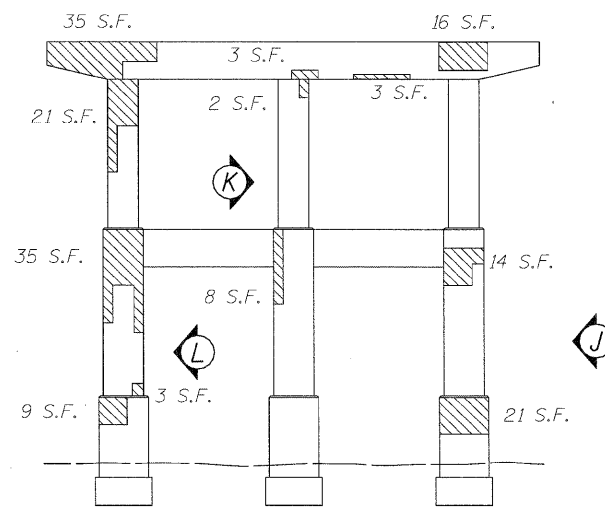
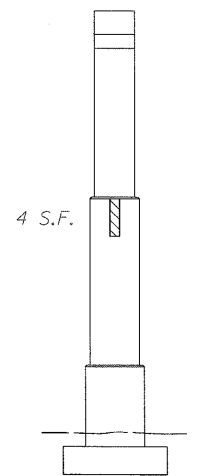
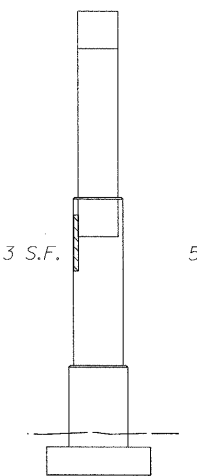
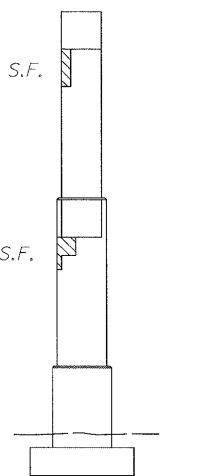
- Structural Repair of Concrete (Depth < 5") = 302 Sq. Ft.
- Structural Repair of Concrete (Depth > 5") = 18 Sq. Ft.
