PIER 7 & 8 REPAIRS

EASTBOUND FAI-80 OVER RAILROADGARDNER STREET

STRUCTURE NO. 099-0060

SHEET NO. S-8 OF 15 SHEETS

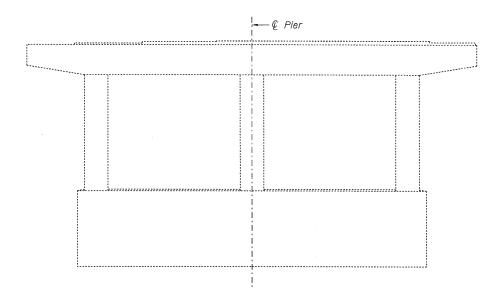
PIER 8 - WEST ELEVATION

Looking East

Areas of proposed pier repairs are estimated. Actual type, location and dimensions of pier repairs are to be determined by the Engineer during construction.

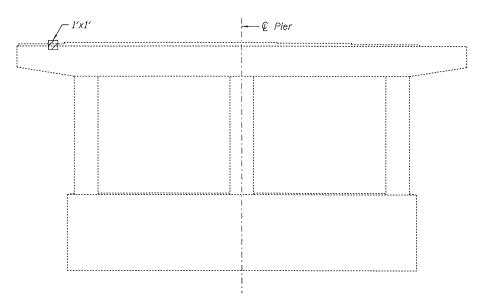
PIER 7 - EAST ELEVATION

Looking West

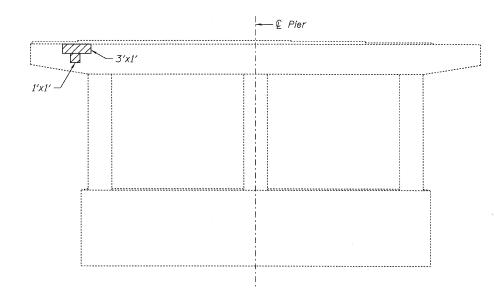
## PIER 8 - EAST ELEVATION

Looking West
