STATE OF ILLINOIS
DEPARTMENT OF TRANSPORTATION

PIER 3 REPAIRS
EASTBOUND FAI-80 OVER HICKORY CREEK
STRUCTURE NO. 099-0062
SHEET NO. S-5 OF 7 SHEETS

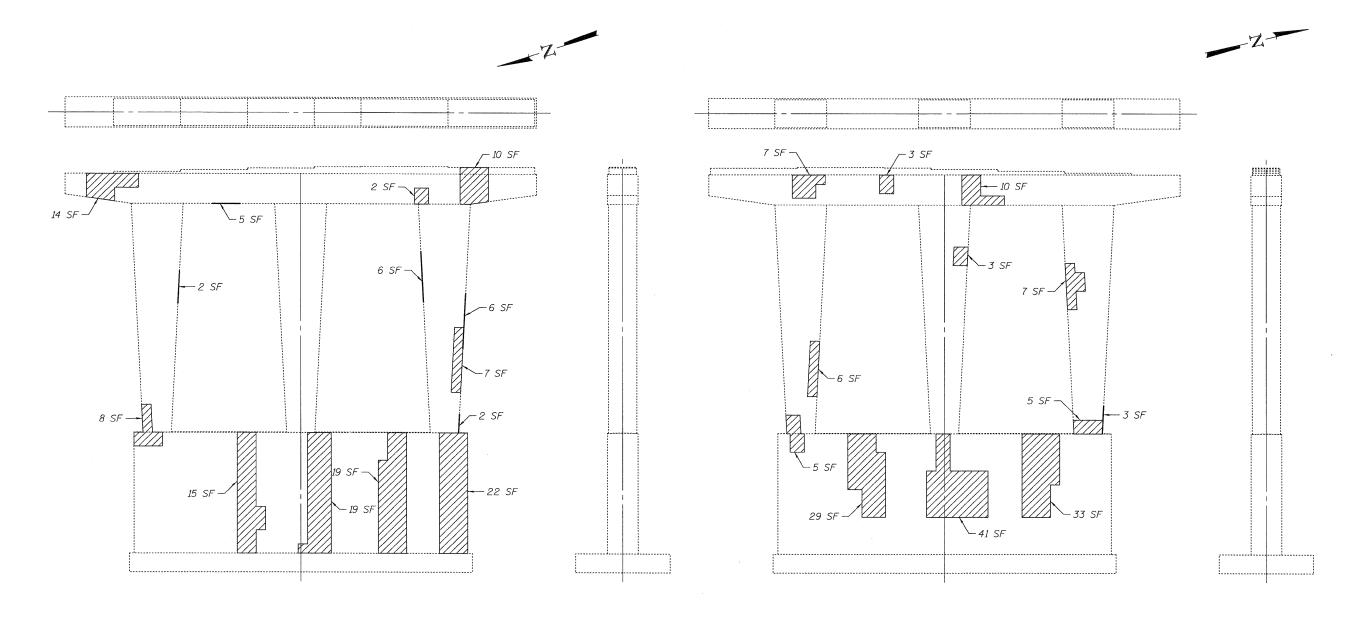
WEST ELEVATION
Looking East

SOUTH ELEVATION

Looking North

EAST ELEVATION

Looking West

NORTH ELEVATION

Looking South

Spalled or unsound concrete - SF indicates Square Feet.

ITEM	UNIT	TOTAL
Structural Repair Of Concrete (Depth Greater Than 5 Inches)	Sq.Ft.	14
Structural Repair Of Concrete (Depth Equal To Or Less Than 5 Inches)	Sq.Ft.	275

Areas of proposed pier repairs are estimated. Actual type, location and dimensions of pier repairs are to be determined by the Engineer during construction.
