DECK PLAN - Structure 081-0100 Northbound

DECK PLAN & CROSS-SECTION
I-74 OVER 19th STREET
FAI 74 (I-74)
SECTION 81-(1-2,1,2-2)RS-1 & M
ROCK ISLAND COUNTY
STRUCTURE NUMBER 081-0100 (NB)

Sheet 12 of 18

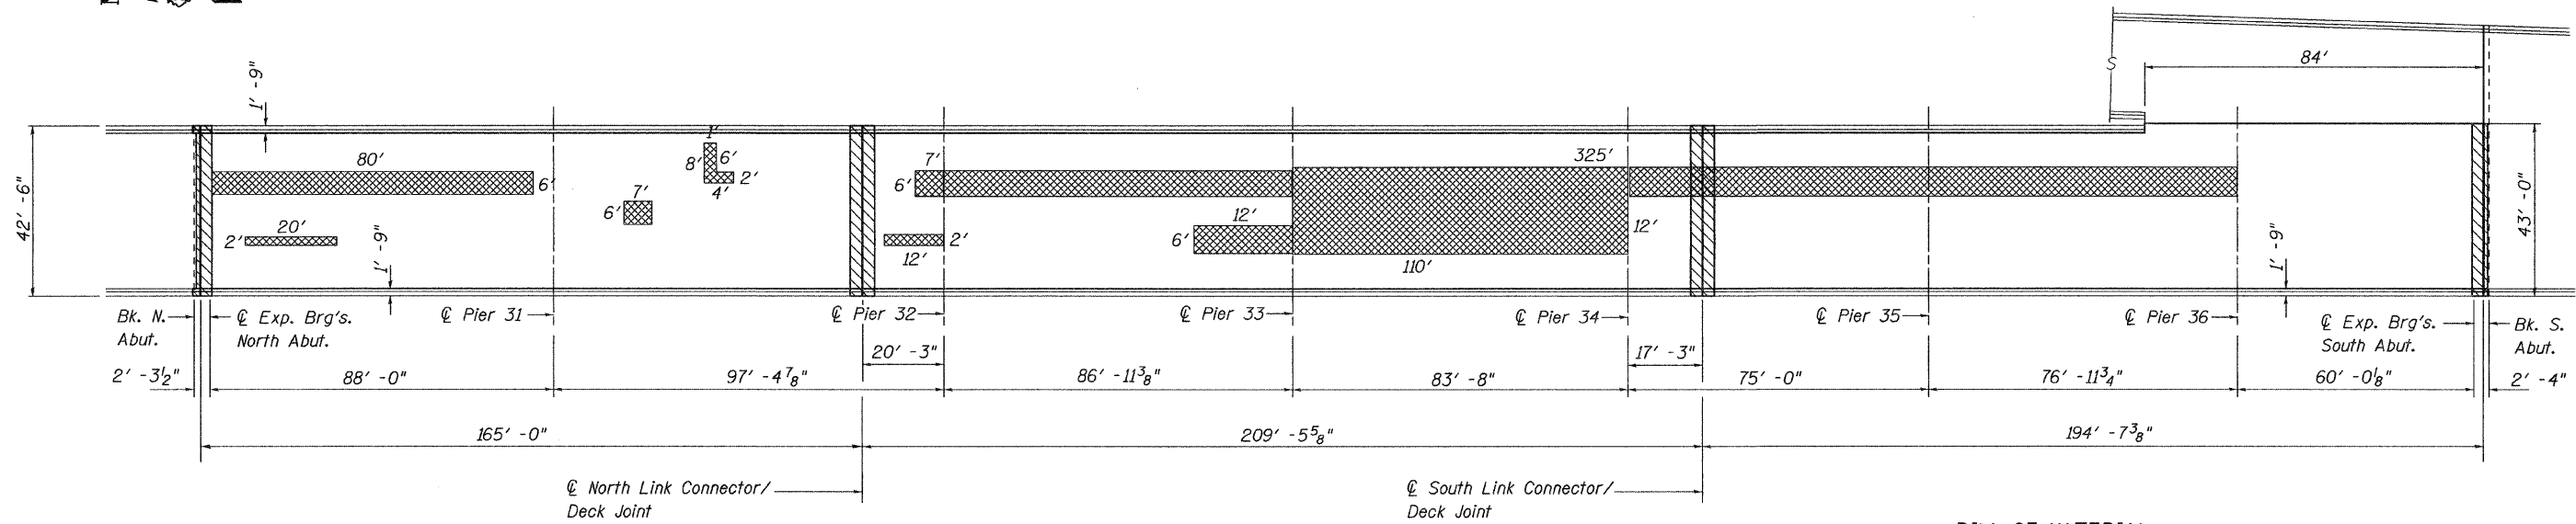
Potential Full Depth Deck Repair

Concrete Removal

Date of Survey: 05/02/2008
