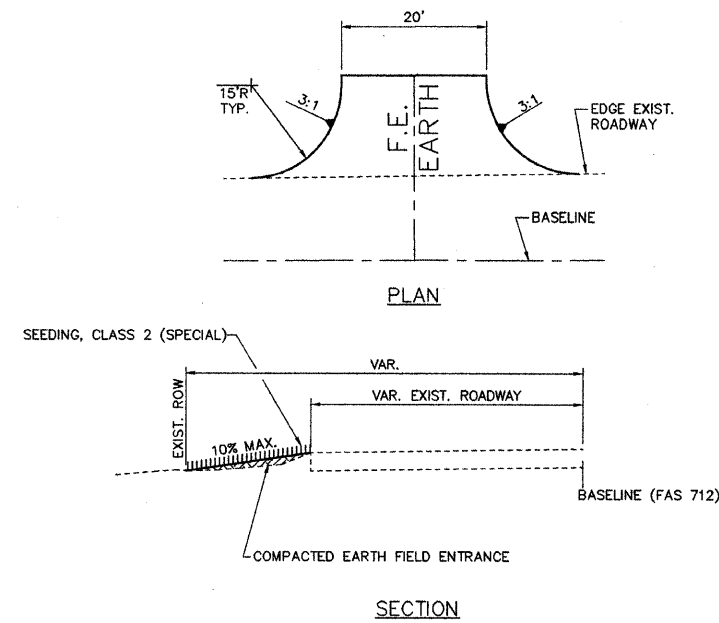
TYPICAL FIELD ENTRANCE
 3:1 OR FLATTER SIDE SLOPES
 LT., STA. 142+80
 RT., STA. 155+50

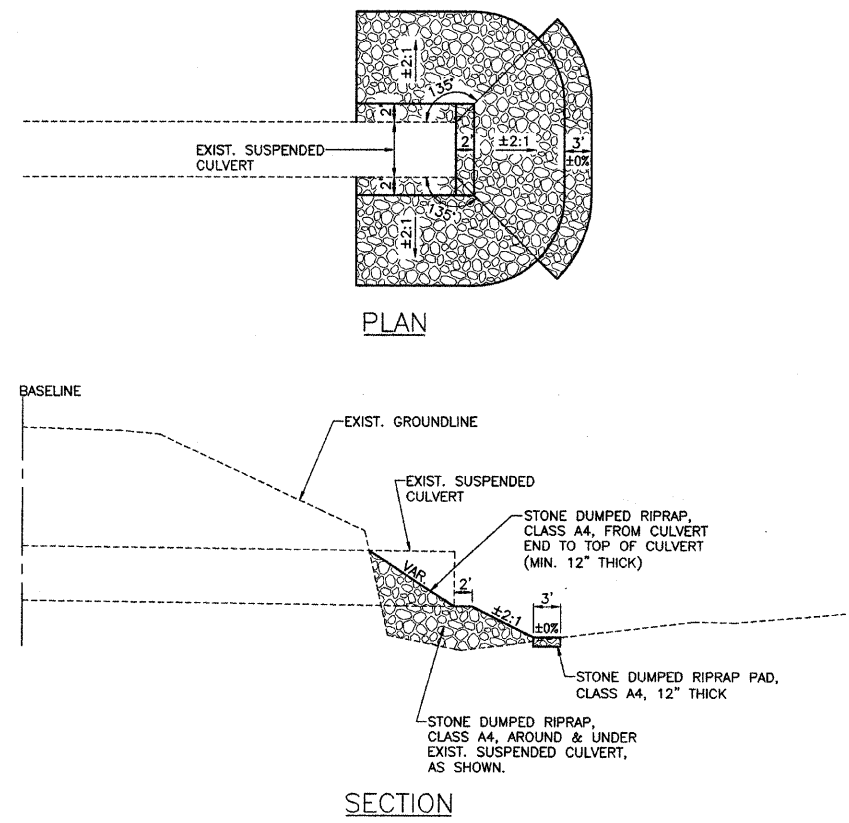
RIPRAP DETAIL AT EXISTING SUSPENDED CULVERT
