SUBSTRUCTURE REPAIR DETAIL

SN 098-0051 PIER #3 (NORTH FACE - LOOKING SOUTH)

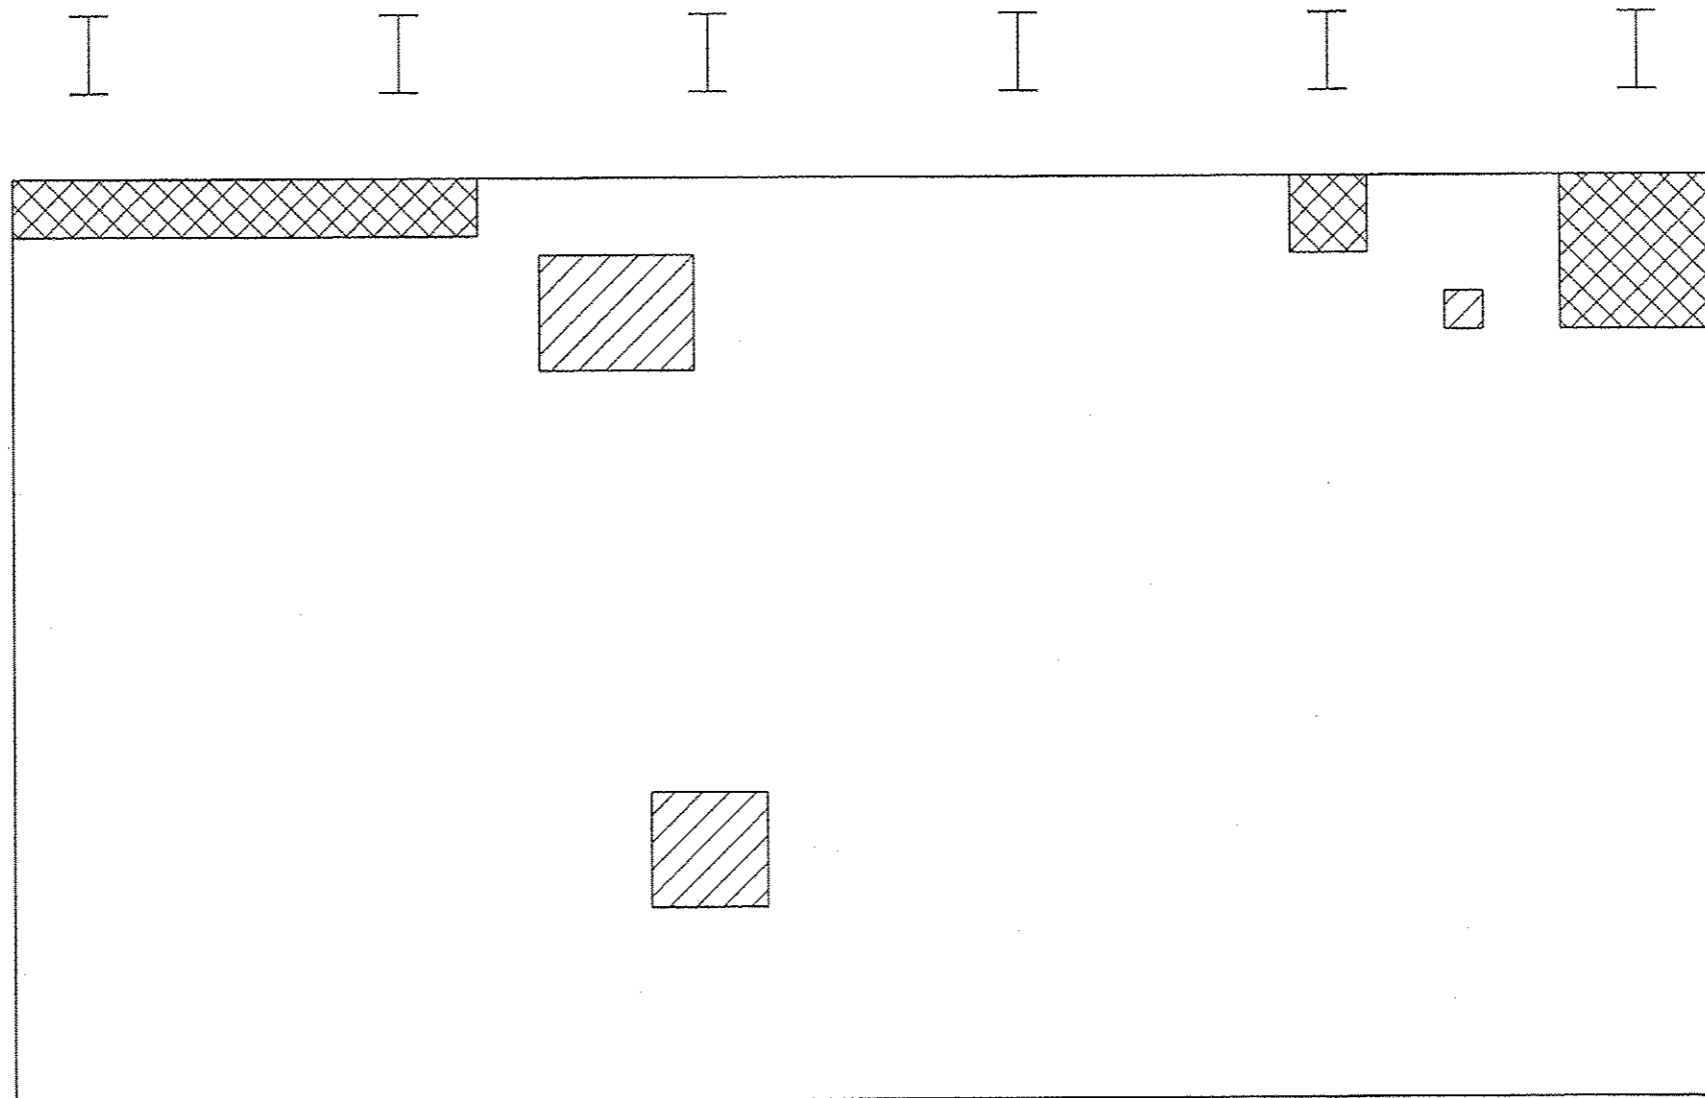
- J JACKING AND CRIBBING LOCATION
- DELAMINATED AREA $>$ 5"
- DELAMINATED AREA \leq 5"

ITEM	QUANTITY
(*) STRUCTURAL REPAIR OF CONCRETE \leq 5"	22.0 (SQ FT)
(*) STRUCTURAL REPAIR OF CONCRETE $>$ 5"	38.0 (SQ FT)
TEMPORARY SHORING AND CRIBBING	1 (EACH)

(*) THIS IS AN ESTIMATED QUANTITY. THE ACTUAL LOCATION OF DELAMINATED AREAS AND QUANTITIES WILL BE DETERMINED BY THE RESIDENT ENGINEER IN THE FIELD.
