**PARTIAL PLAN**

ILLINOIS DEPARTMENT OF TRANSPORTATION  
**DECK REPAIR-3**  
**F.A.P. 326 (IL RTE. 47)**  
**OVER FOX RIVER**  
**SECTION (108,109)RS-4**  
**KENDALL COUNTY**  
**S.N. 047-0048**

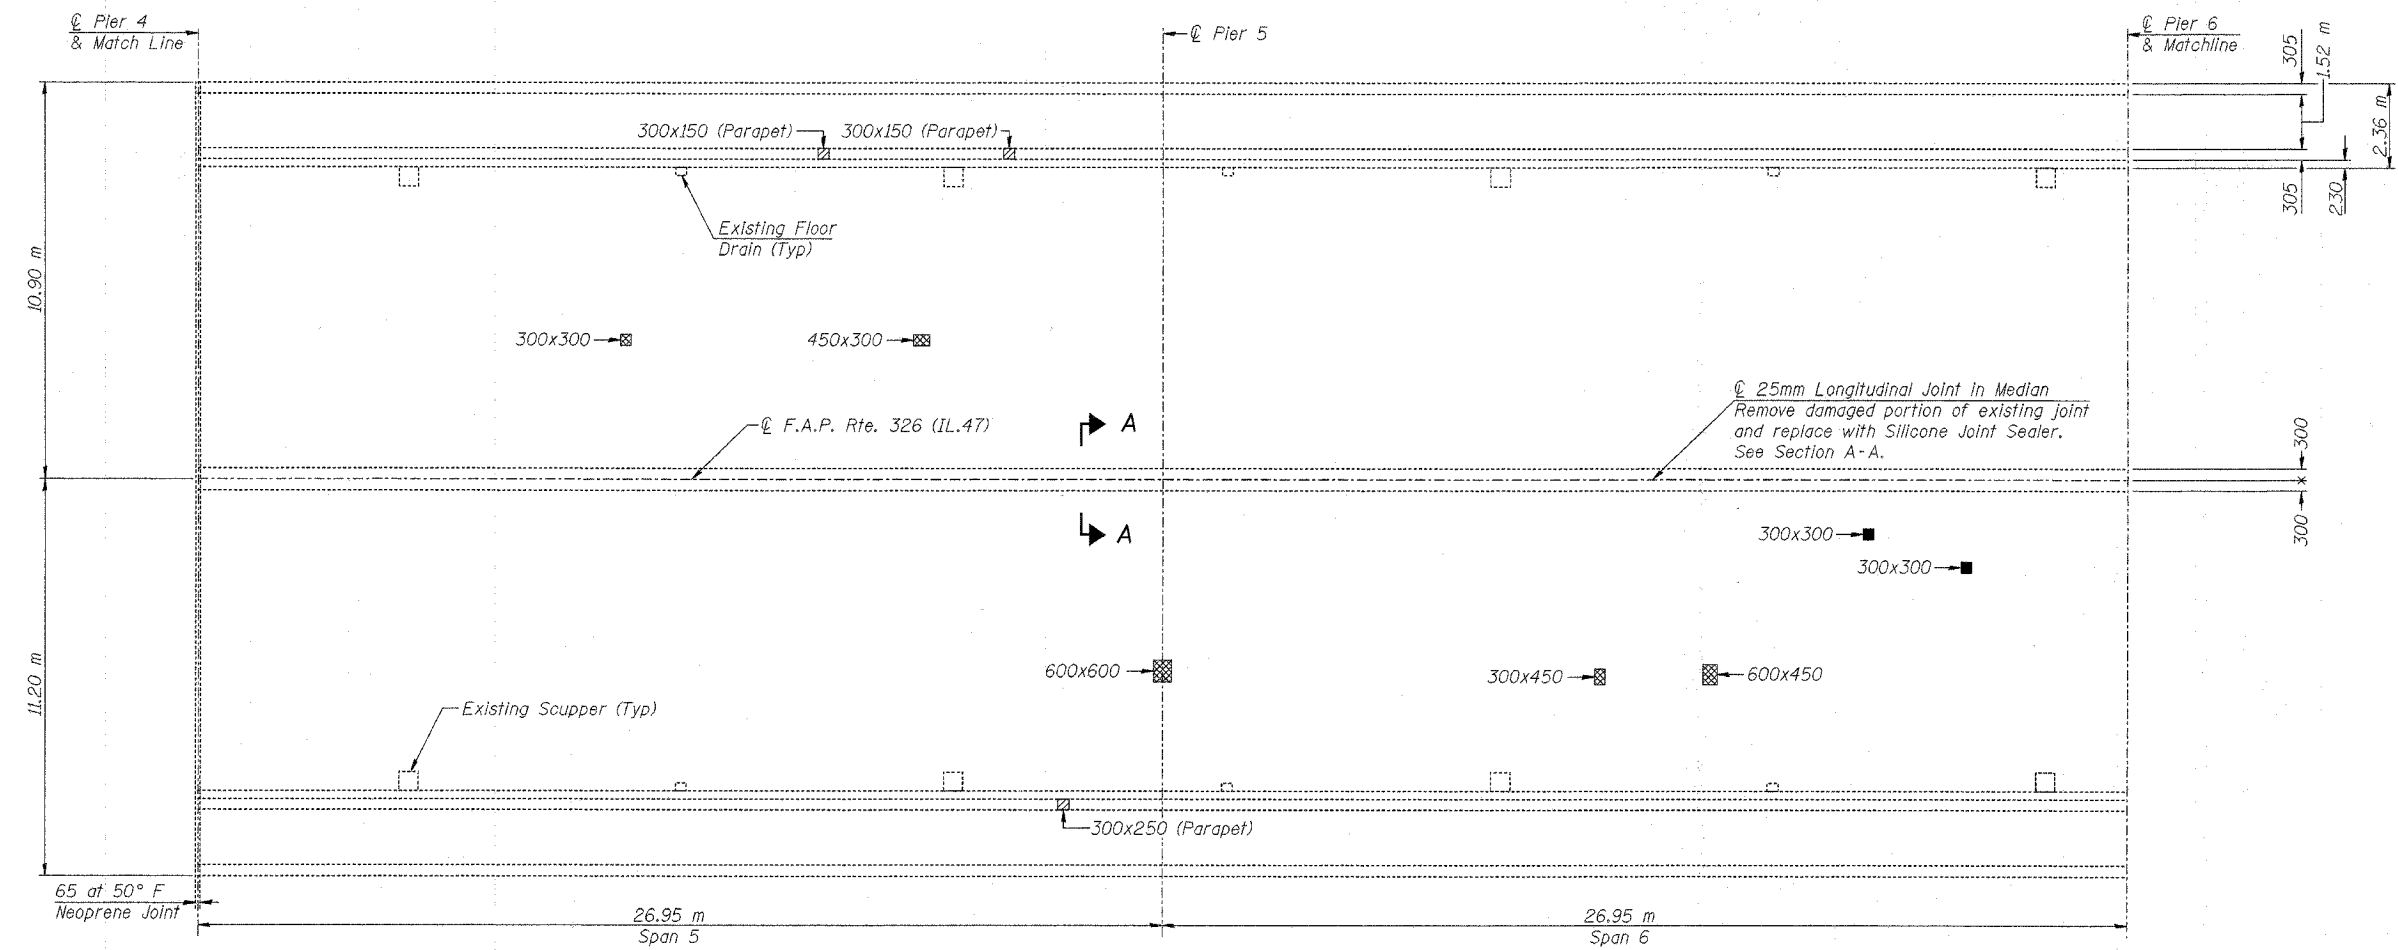
Notes: For details of Deck Slab Repair see Special Provision for "Deck Slab Repair."  
 See Sheet #6 of 8 for Cross Section.  
 For Sec. A-A see Sheet #3 of 8.  
 The quantities shown for estimating purposes only. Area to be repaired will be determined by the Engineer at the time of Construction. Actual repair locations shall be shown on the same as-built plans.
