## STATE OF ILLINOIS DEPARTMENT OF TRANSPORTATION

\* (5VB, 5HB, 1-2HB)M CONTRACT #64A88

DECK REPAIR PLAN F.A.P. Route 303 & FAB 738 (IL 251) OVER Railroad SECTION (5VB, 5HB, 1-2HB)M WINNEBAGO COUNTY SN 101-0029

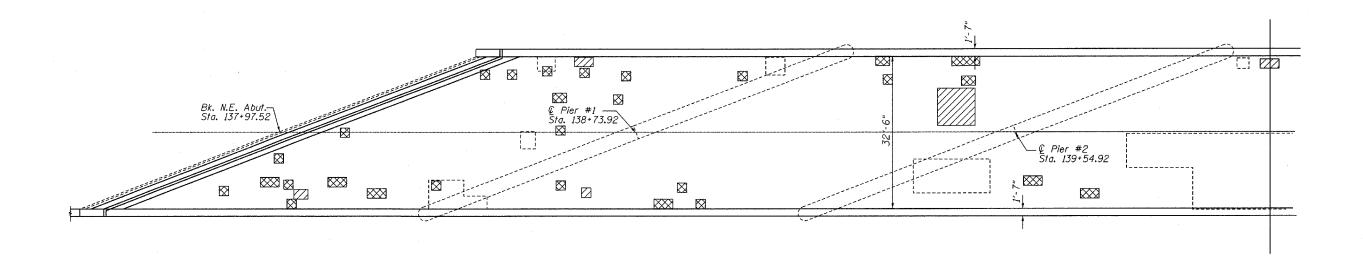
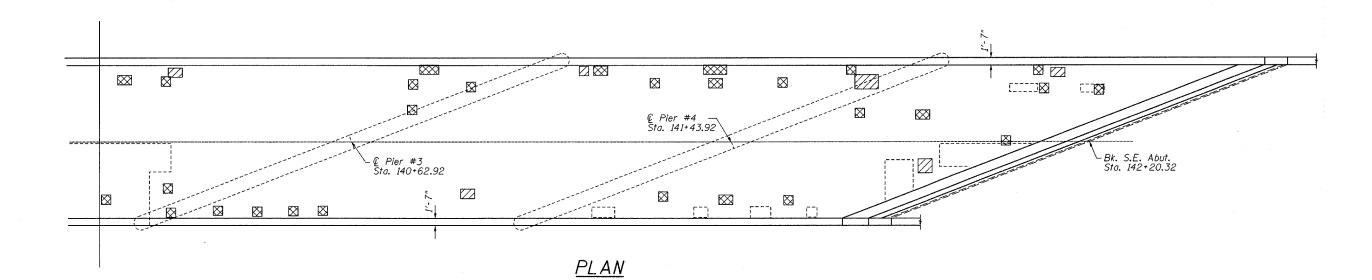
Deck Slab Repair (Partial)

Existing Deck Slab Repair

Deck Slab Repair (Full Depth)

The plan quantities for Deck Slab Repair (Partial and Full Depth) are estimated quantities from a deck survey provided by others. The areas shown on the deck repair plans for each structure are potential areas of Deck Slab Repair, The Deck Slab Repair quantities in Bills of Material are included as contingencies to be used as directed by the engineer during construction. The actual locations and quantity of Deck Slab Repair on all structures shall be determined by the resident engineer in the field after removal of the existing wearing surface. Actual repair locations shall be shown on the same as-built plans.
