ELEVATION VIEW
IL 83 SB
LOOKING SOUTH

ELEVATION VIEW
IL 83 NB
LOOKING SOUTH

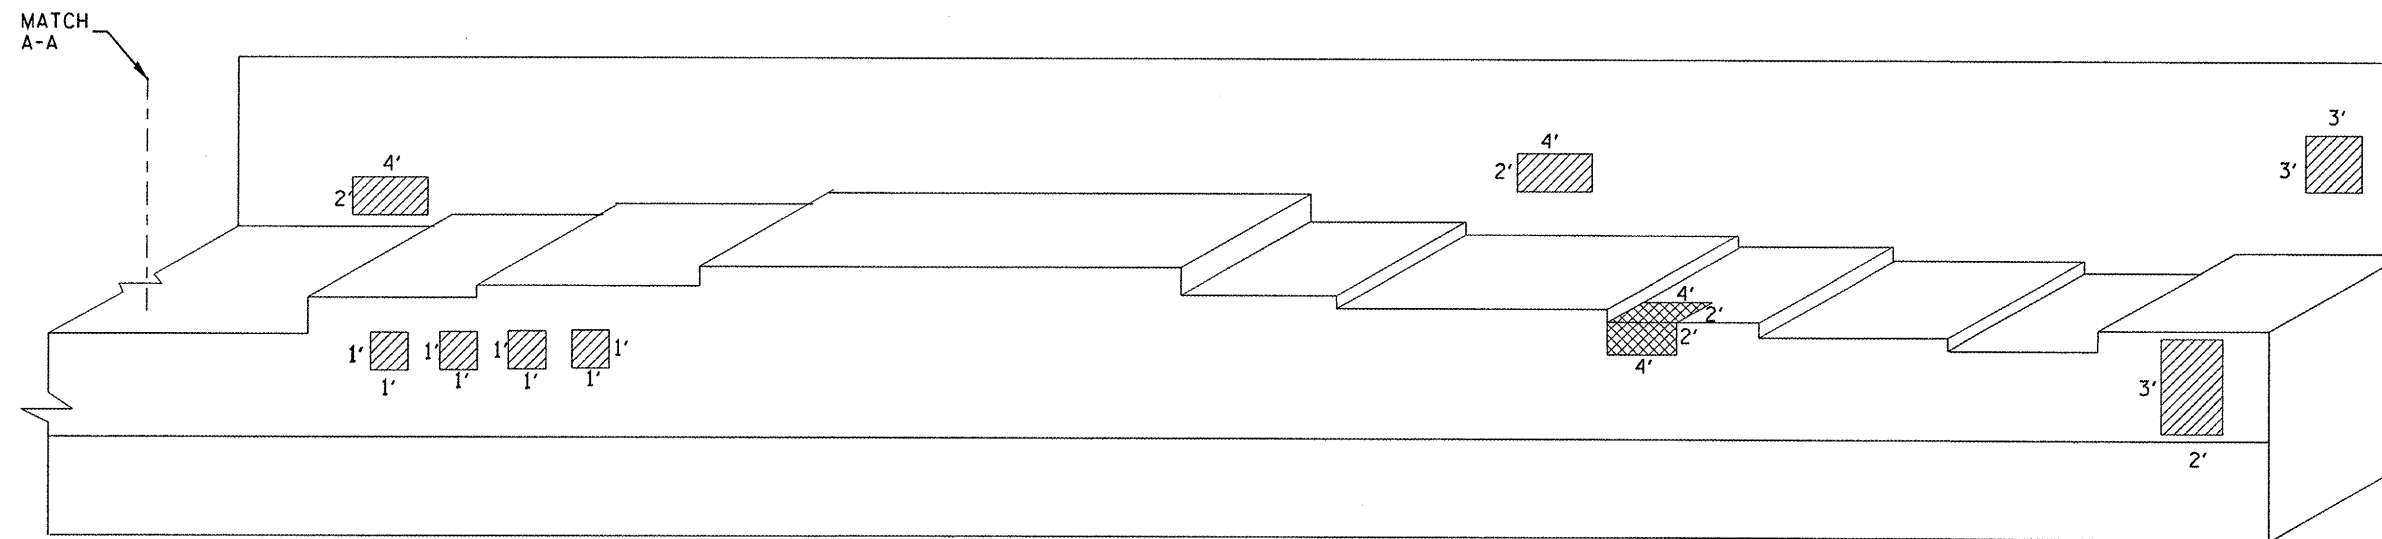
- STRUCTURAL REPAIR OF CONCRETE > 5"
- STRUCTURAL REPAIR OF CONCRETE ≤ 5"
