**TIMBER CURB & HMA CURB REPAIR**

FILE NAME =		USER NAME = quigleyml		DESIGNED -	REVISED -	<b>STATE OF ILLINOIS DEPARTMENT OF TRANSPORTATION</b>	<b>TIMBER CURB &amp; BITUMINOUS CURB REPAIR &amp; GUARD POST DETAIL</b>			F.A. RTE.	SECTION	COUNTY	TOTAL SHEETS	SHEET NO.
c:\pwwork\pwwork\quigleyml\d02588015\036829-sh-t-DETAILS.dgn		DRAWN -	REVISED -	SCALE:	SHEET NO.					OF SHEETS	STA.	TO STA.	VAR.	
PLOT SCALE = 50,0000' / IN.		CHECKED -	REVISED -						CONTRACT NO. 66B29					
PLOT DATE = Apr 07, 2011 - 11:42:39 AM		DATE -	REVISED -						ILLINOIS FED. AID PROJECT

• D-3 HIGHWAY DAMAGE REPAIR 2011

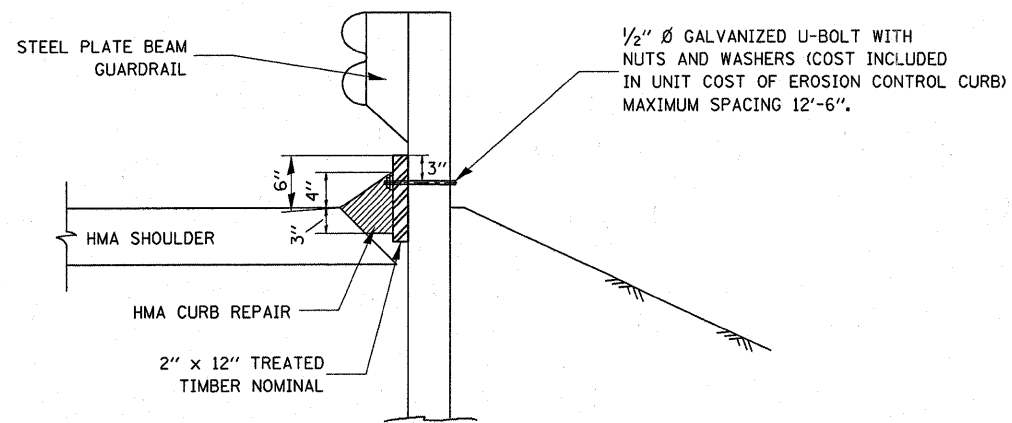
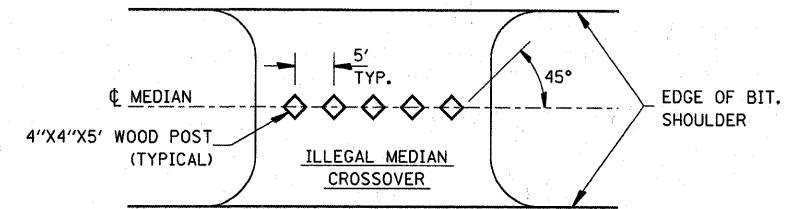
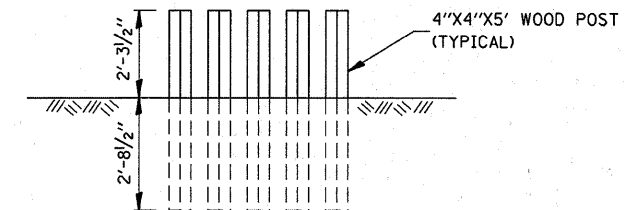
SPLICE PLATE 2" x 12", 2' LONG WITH #16 GALVANIZED NAIL TO THE TREATED TIMBER CURB (COST INCLUDED). SPLICE PLATE TO BE TREATED TIMBER.

**NOTE:**  
 THE TREATED TIMBER SHALL BUTT TOGETHER AT THE GUARDRAIL POST OR SPLICED AS SHOWN ON THE DETAIL.  
 THE TREATED TIMBER SHALL BE TREATED IN ACCORDANCE TO ARTICLE 1007.12 AND ALL PRESERVATIVES SPECIFIED IN THE ARTICLE WILL BE ALLOWED.  
 THE PRICE FOR EROSION CONTROL CURB SHALL INCLUDE THE U-BOLTS ATTACHING THE TREATED TIMBER TO THE GUARDRAIL POSTS, TREATED TIMBER, AND THE NECESSARY GRADING TO COMPLETE THIS WORK.  
 HMA CURB REPAIR SHALL BE MEASURED AND PAID FOR AT CONTRACT UNIT PRICE PER TON.  
 HMA CURB REPAIR SHALL BE IN ACCORDANCE WITH SECTION 408 OF THE STANDARD SPECIFICATIONS.
