STATE OF ILLINOIS
DEPARTMENT OF TRANSPORTATION

PIER 2
REPAIR DETAILS
STRUCTURE NO. 016-0519

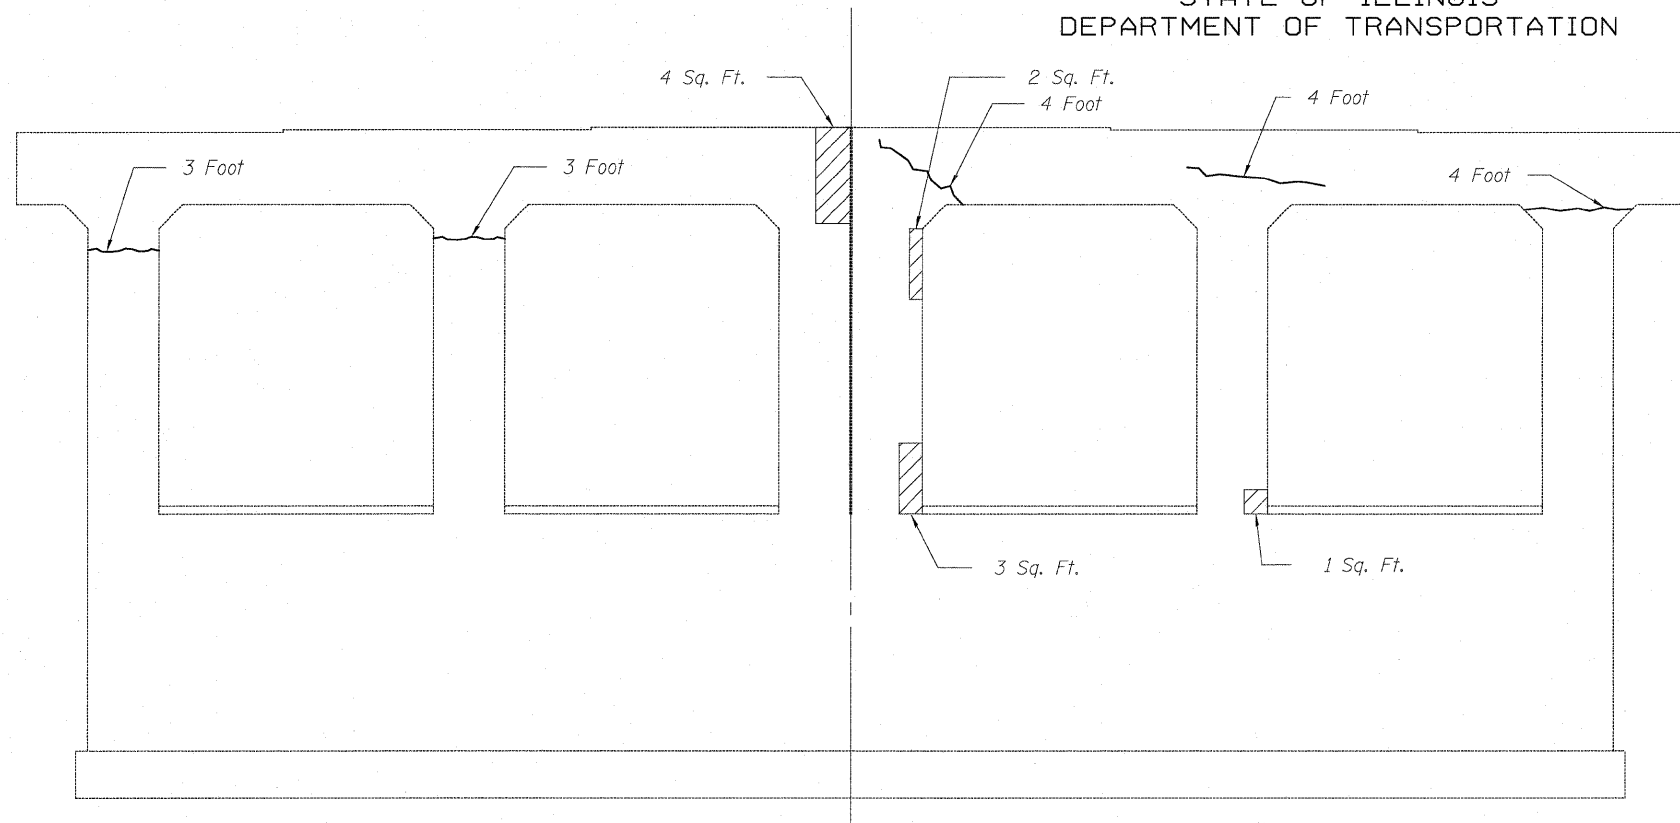
WEST FACE

Structural Repair of Concrete (Depth Equal to or Less Than 5")
-

Epoxy Crack Injection
