STATE OF ILLINOIS
DEPARTMENT OF TRANSPORTATION

ROUTE NO.	SECTION	COUNTY	STATIONING	SHEET NO.	SHEET NO. 14 16 SHEETS
FAP 132	IBR-2	SALINE	114	56	
FED. ROAD DIST. NO.		SUBSECTION	FED. AID PROJECT-

PIER
IL 34/145 OVER SOUTH FORK SALINE RIVER
FAP ROUTE 132 - SECTION IBR-2
SALINE COUNTY
STATION 235+10.00
STRUCTURE NO. 083-0019

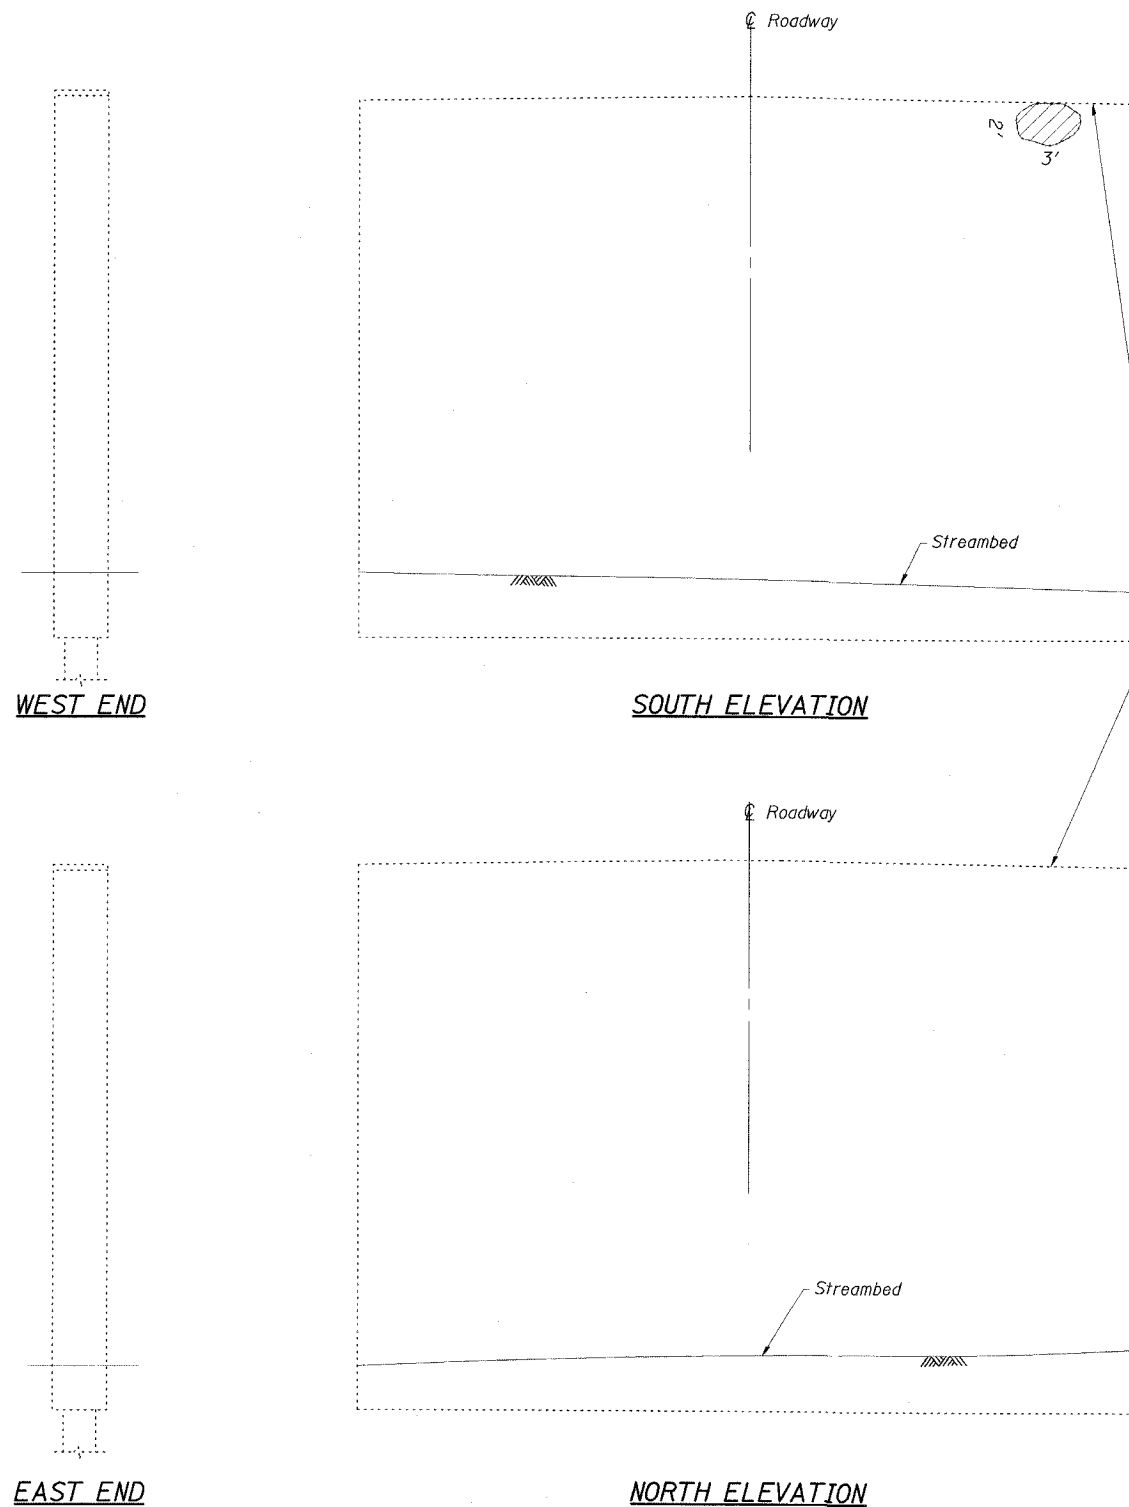
EXISTING BEARING SEAT TO BE INSPECTED BY THE ENGINEER AFTER DECK BEAM REMOVAL. DETERIORATED CONCRETE AREAS SHALL BE REPAIRED (ESTIMATED 15 S.F. STRUCTURAL REPAIR OF CONCRETE DEPTH \leq 5") AND CRACKS SHALL BE SEALED (ESTIMATED 20' EPOXY CRACK INJECTION) IF FOUND. CONCRETE SEALER SHALL BE APPLIED TO STRUCTURAL REPAIR OF CONCRETE AREAS.

NOTE: PIER CRACK REPAIR LENGTHS AND STRUCTURAL REPAIR OF CONCRETE AREAS ARE ESTIMATED FROM 02-01-07 SURVEY WORK. ACTUAL LOCATIONS AND QUANTITIES OF REPAIRS SHALL BE SHOWN BY THE ENGINEER ON THE AS-BUILT PLANS FOR THIS SECTION.
