Contract # 66586

SHEET NO. 220
313 SHEETS

CONCRETE REPAIR - SOUTH ABUT. (NB)
ABRAHAM LINCOLN MEMORIAL BRIDGE OVER
THE ILLINOIS RIVER (PUBLIC WATERS)
F.A.I. ROUTE 39 SEC. (50-4B) BR
LASALLE COUNTY
STATION 863+16.00
STRUCTURE NO. 050-0191 (SB & NB)

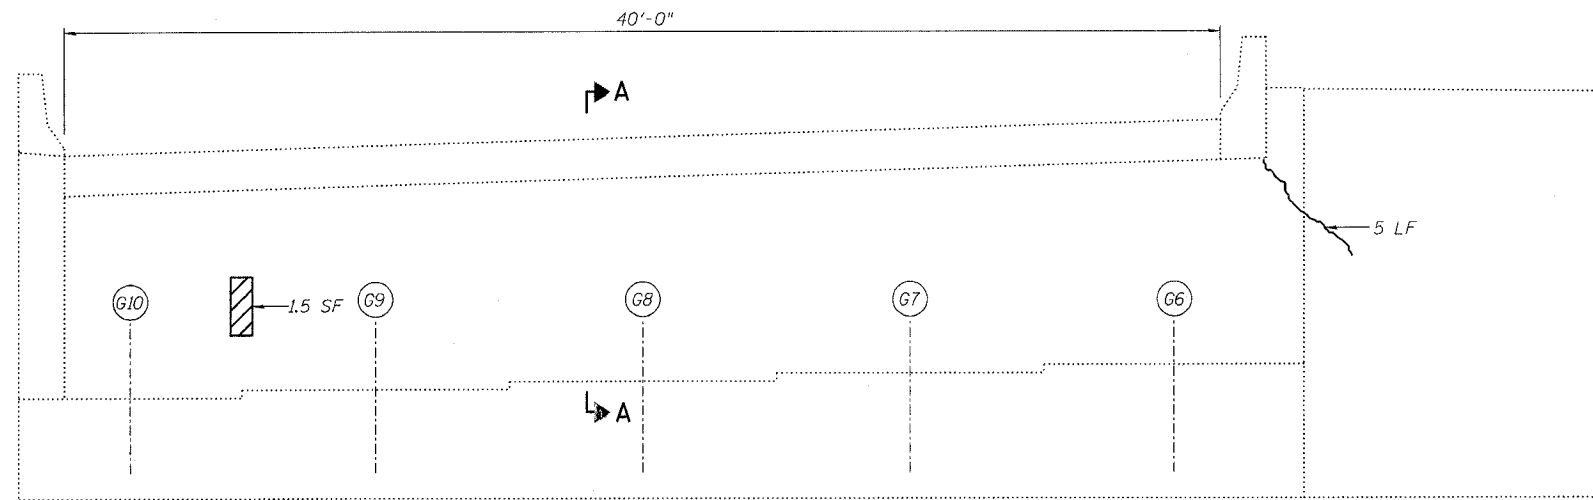
NORTHBOUND ELEVATION
(Looking South)

The quantities shown are for estimating purposes only. The area to be repaired will be determined by the Engineer at the time of construction. Actual repair locations shall be shown on the as-built plans.
