STATE OF ILLINOIS
DEPARTMENT OF TRANSPORTATION

ROUTE NO. F.A.I. 39	SECTION 50-4B	COUNTY LASALLE	TOTAL SHEETS 283	SHEET NO. 283	SHEET NO. 260 313 SHEETS
FED. ROAD DIST. NO. 7		ILLINOIS		FED. AID PROJECT

Contract # 66586

PIER REPAIR - PIER 17 SB
ABRAHAM LINCOLN BRIDGE OVER
THE ILLINOIS RIVER (PUBLIC WATERS)
F.A.I. ROUTE 39 SEC. (50-4B) BR
LASALLE COUNTY
STATION 863+16.00
STRUCTURE NO. 050-0191 (SB & NB)

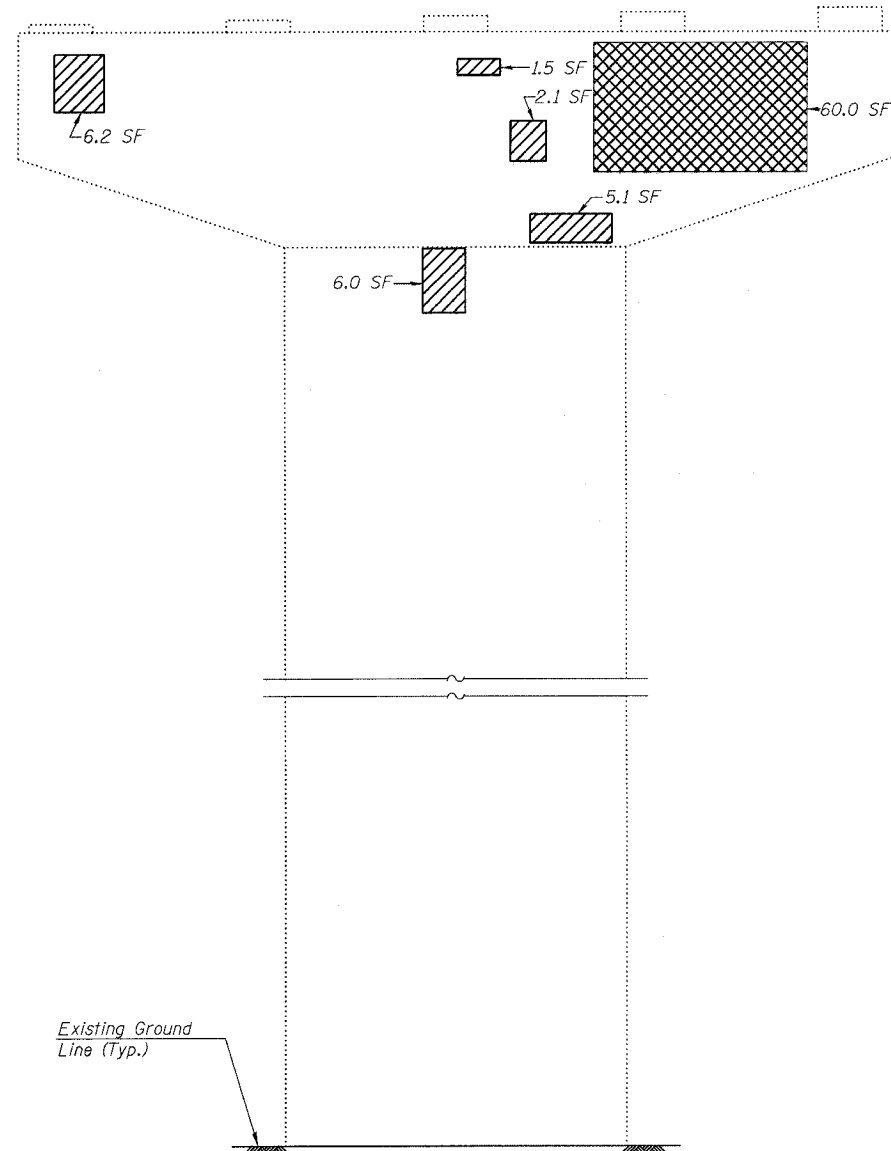
ELEVATION
(Looking North)

- The quantities shown are for estimating purposes only. The area to be repaired will be determined by the Engineer at the time of construction. Actual repair locations shall be shown on the as-built plans.
- See Sheet 262 for rehabilitation of concrete pedestals.
