ROUTE NO. F.A.I. 39	SECTION 50-4B	COUNTY LASALLE	SHEET 284	SHEET NO. 261 313 SHEETS
FED. ROAD DIST. NO. 7		ILLINOIS	FED. AID PROJECT

**PIER REPAIR - PIER 17 NB**  
**ABRAHAM LINCOLN BRIDGE OVER**  
**THE ILLINOIS RIVER (PUBLIC WATERS)**  
**F.A.I. ROUTE 39 SEC. (50-4B) BR**  
**LASALLE COUNTY**  
**STATION 863+16.00**  
**STRUCTURE NO. 050-0191 (SB & NB)**

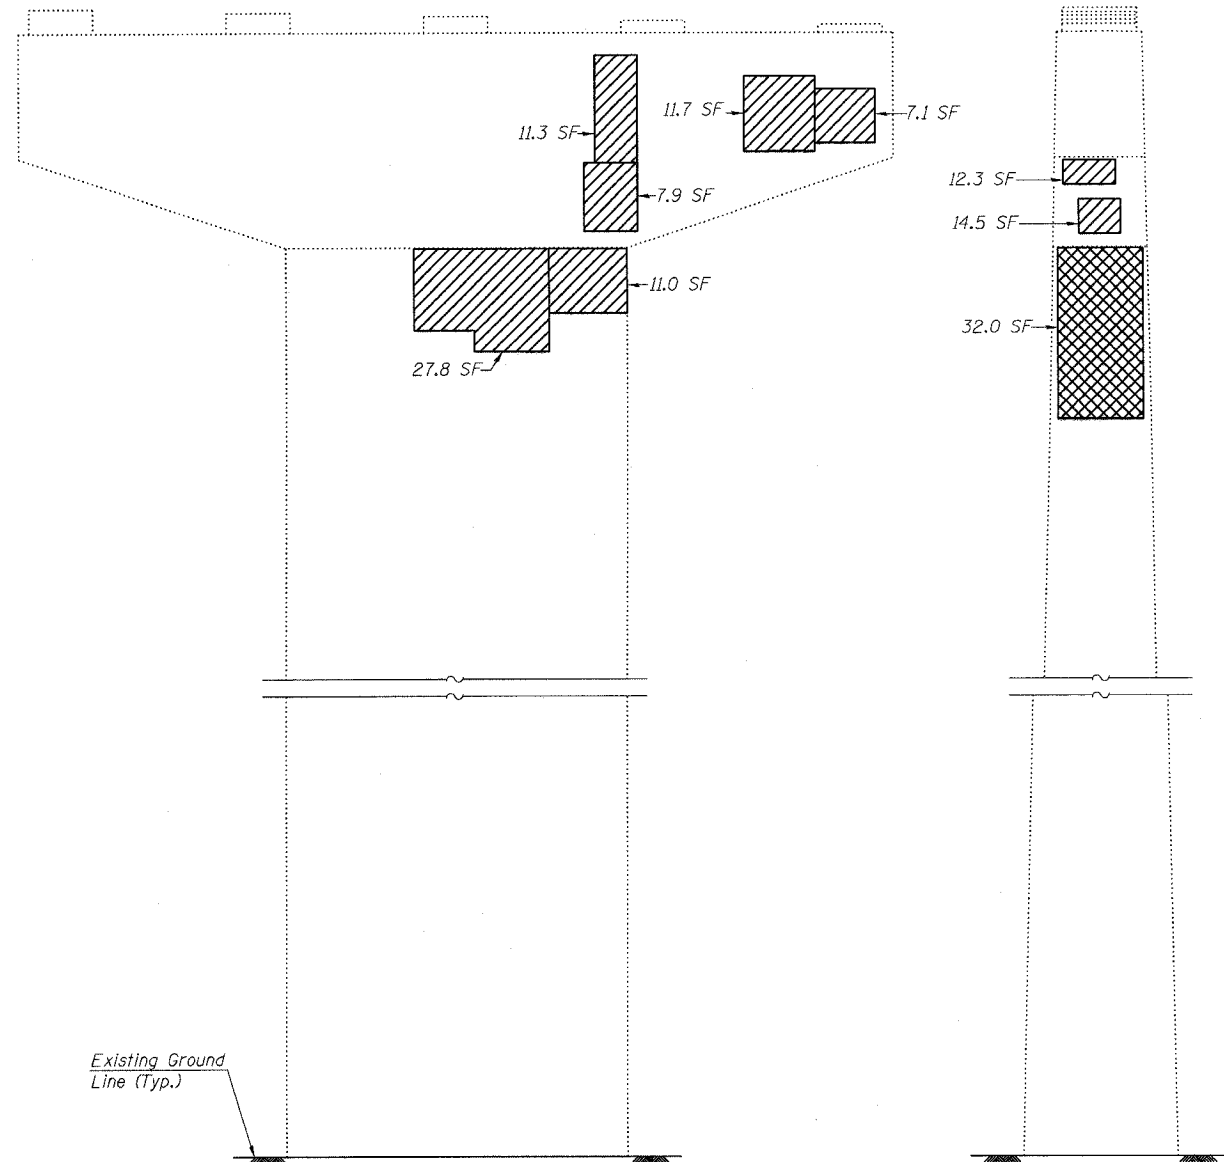
**ELEVATION**  
(Looking North)

**END VIEW**  
(Looking West)

- The quantities shown are for estimating purposes only. The area to be repaired will be determined by the Engineer at the time of construction. Actual repair locations shall be shown on the as-built plans.
- See Sheet 263 for rehabilitation of concrete pedestals.

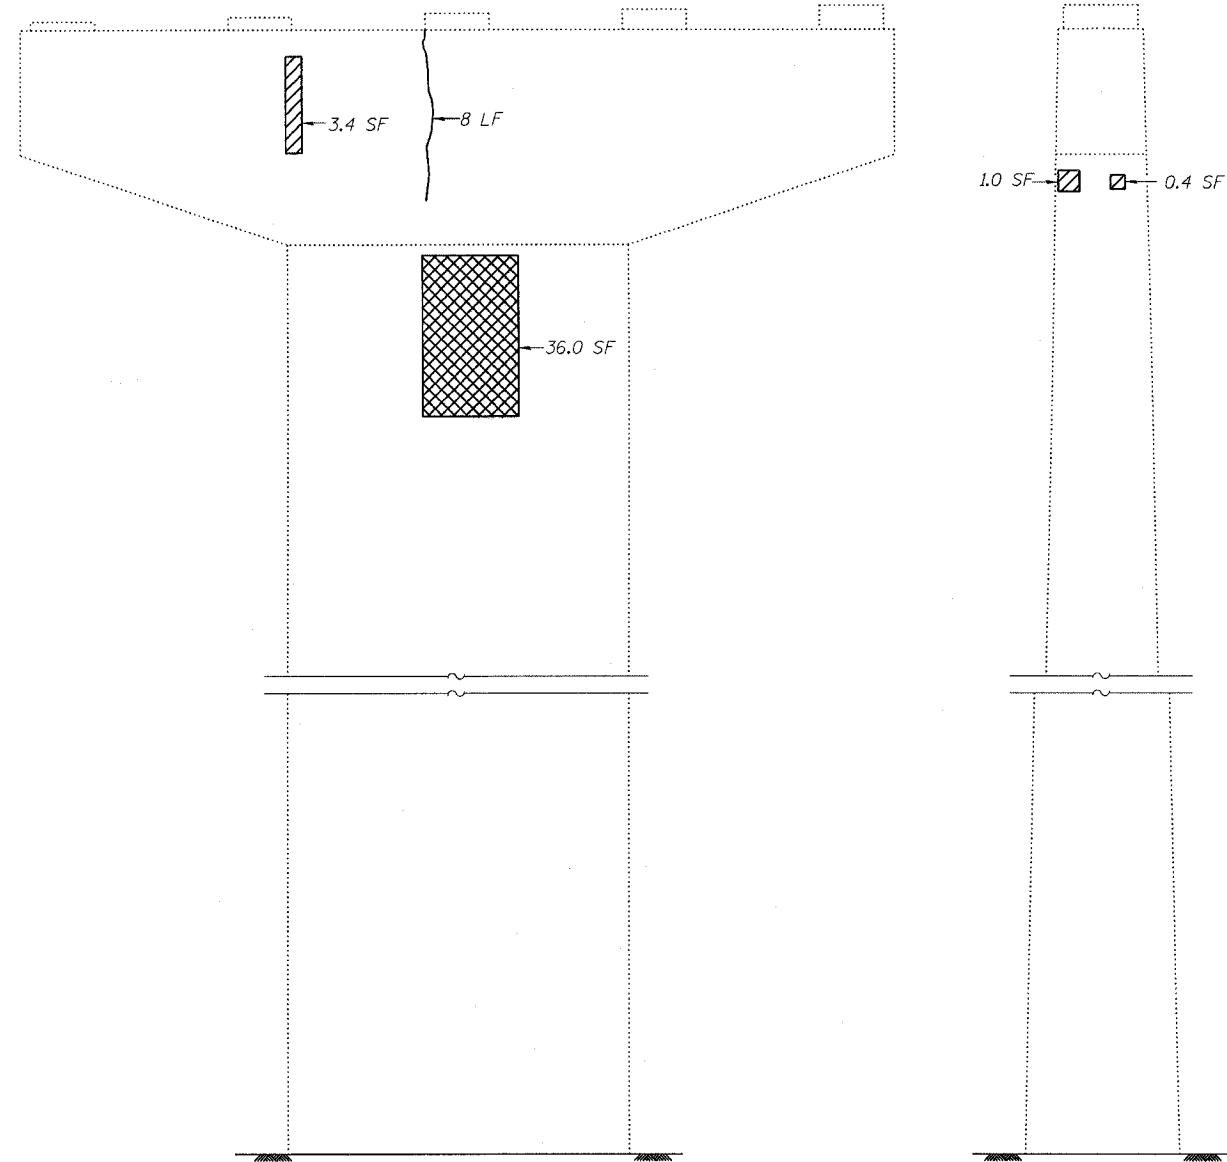
**ELEVATION**  
(Looking South)

**END VIEW**  
(Looking East)
