**EXPANSION JOINT REPAIRS
STRUCTURE NO. 100-0059**

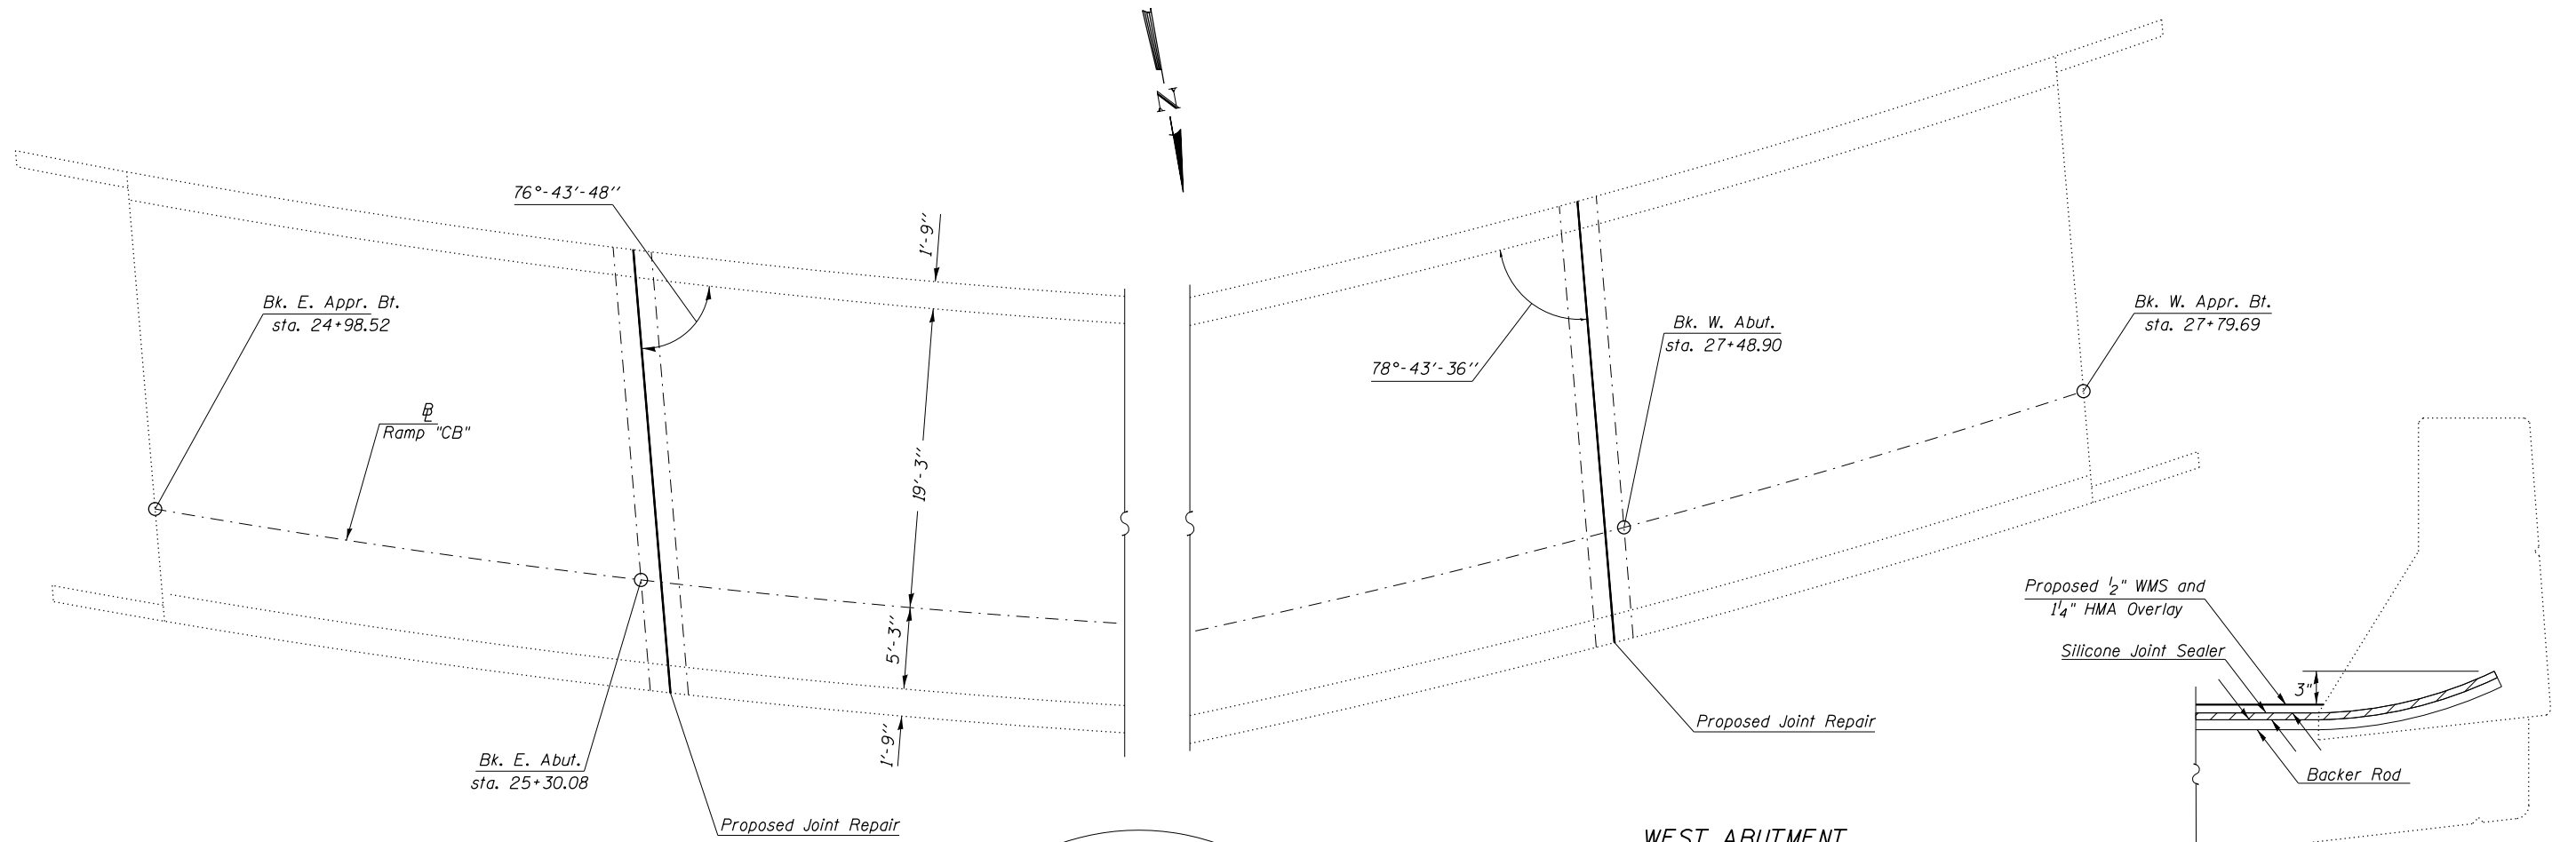
EAST ABUTMENT

WEST ABUTMENT
