STRUCTURAL REPAIR OF CONCRETE  
STRUCTURE NO. 100-0059

**STRUCTURAL REPAIR OF CONCRETE DETAILS**

F.A.I. RTE.	SECTION	COUNTY	TOTAL SHEETS	SHEET NO.
24	D9 CM BRIDGE REP. 2015-1	WILLIAMSON	19	16
CONTRACT NO. 78424			ILLINOIS FED. AID PROJECT

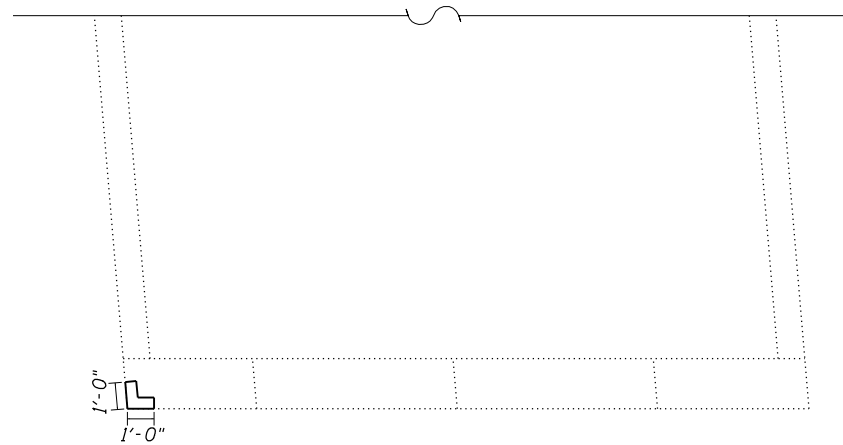
PLAN VIEW

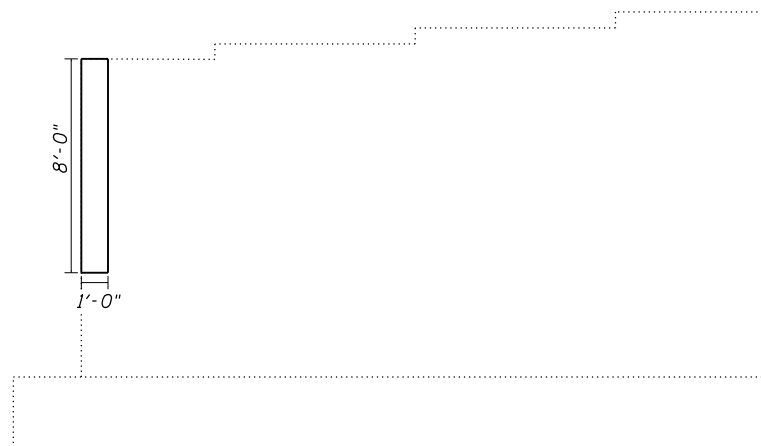
LOOKING NORTH  
AT ABUTMENT

LOOKING FROM  $\phi$  AT ABUTMENT

ELEVATION VIEW  
STRUCTURAL REPAIR OF CONCRETE  
(DEPTH  $\leq$  5 INCHES)  
WEST VAULT
