STATE OF ILLINOIS
DEPARTMENT OF TRANSPORTATION

PIER REPAIR DETAILS
EASTBOUND FAI-80 OVER DES PLAINES RIVER
STRUCTURE NO. 099-0056

SHEET NO. S-25 OF S-35 SHEETS

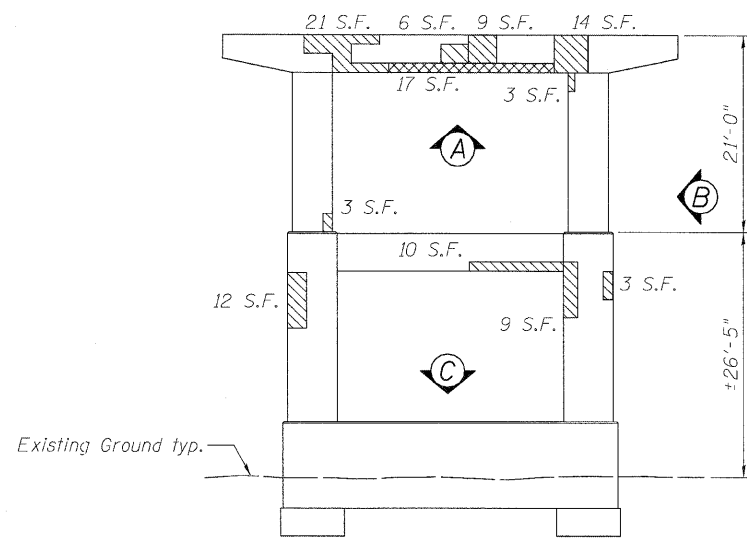
PIER 5

WEST ELEVATION
(Looking East)

Structural Repair of Concrete (Depth < 5") = 590 Sq. Ft.
 Structural Repair of Concrete (Depth > 5") = 247 Sq. Ft.
