SN 099-0008

I-55 (South Bound) over Des Plaines River Smith Bridge

2021 Bridge Inspection Report

Bridge Inspection By: The Illinois Department of Transportation

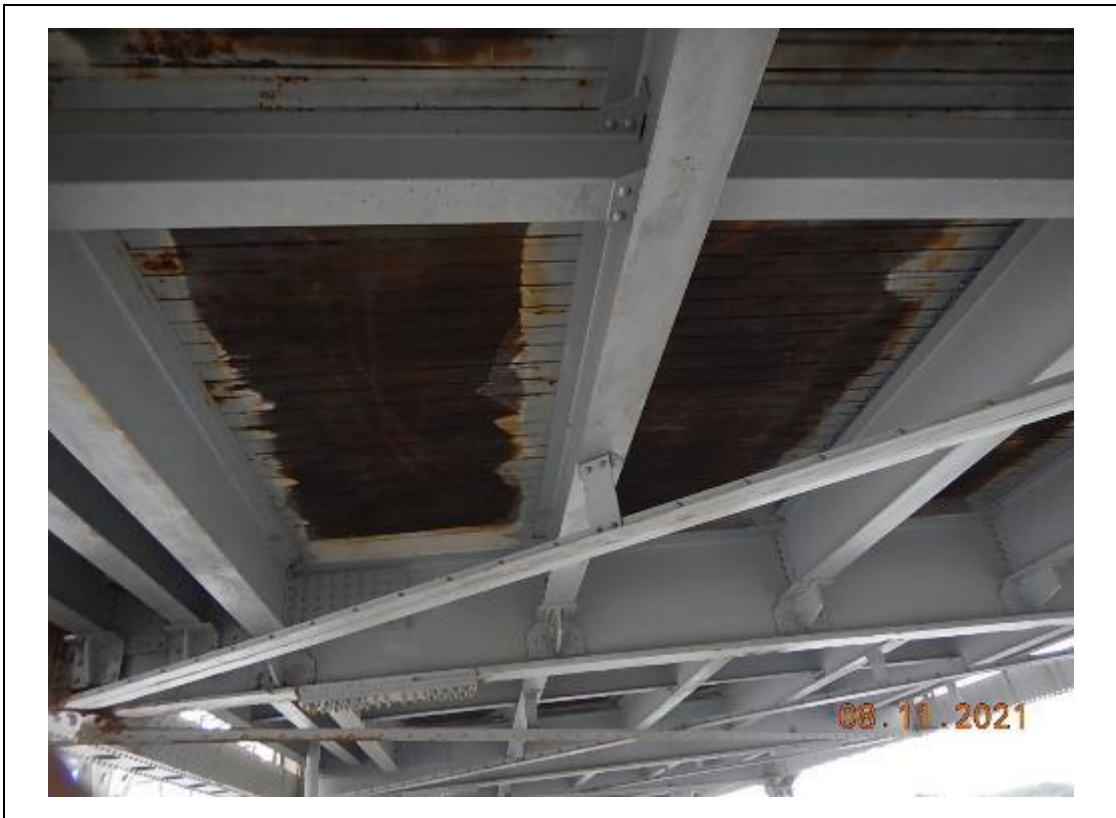
PHOTO 8

Span 4 looking South

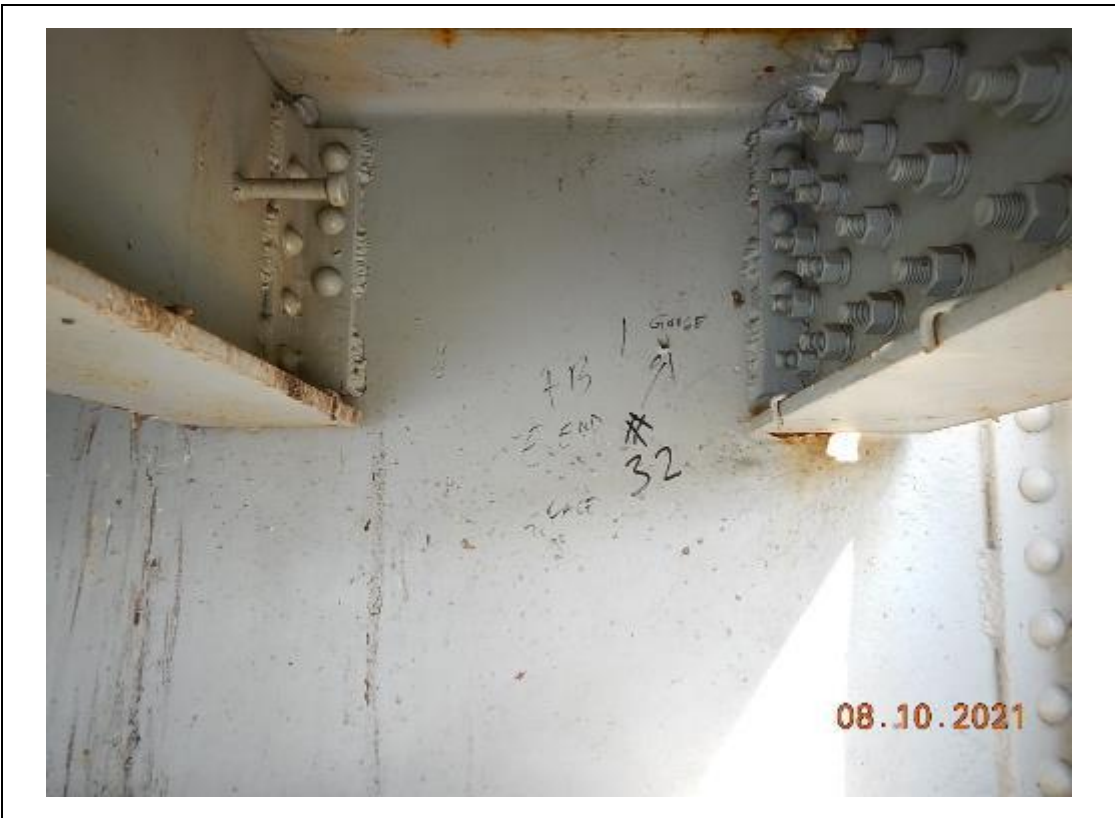
PHOTO 40

Item #	Span(s)	Member(s)	Location(s)	Photo(s)	Deficiency(ies)	Corrective Action	Year	Load Cap. Re-Eval.
32	4	Floorbeam 1	East end	39 LS 40 LN	21% SL Bottom Flange, 4% SL in Web (See Detail 7) 1" X 1/8" Diameter gouge in Web	N/A 21% SL , IRF=1.96	2011/ 2013	
33	4	Stringer 7	Panel 2, North end, East face	41 LNW	1 fully craked weld (connection Plate to Web), 2 part cracked welds (Form to connection Plate) (face of dead load counter weight)	N/A	2015	
34	4	L1W-L2W	at L1W	42 LW	5% SL , in Channels (See Detail 8)	N/A 5 % SL , IRF=4.63	2011/ 2013	
137	4	L1W-L2E	at L1W	43 LNW	15% SL , 2" area SL with 1" Hole	N/A	2017	
35	4	L1E-L2E	4' South of L1E, Top Plate	44 LW	0% SL , 1" Hole in Top Plate	N/A	2015	
36	4	U1E-L2E	3' from L2E	45 LW 46 LE	6% SL , 6" X 3' L area of loss with 3" hole and a 1" hole in Channel	N/A 6% SL , IRF=1.93	2009	
37	4	L1E-L2W	at L2W	47 LE	35% SL , 4" Hole horizontal leg	N/A	2011/ 2013

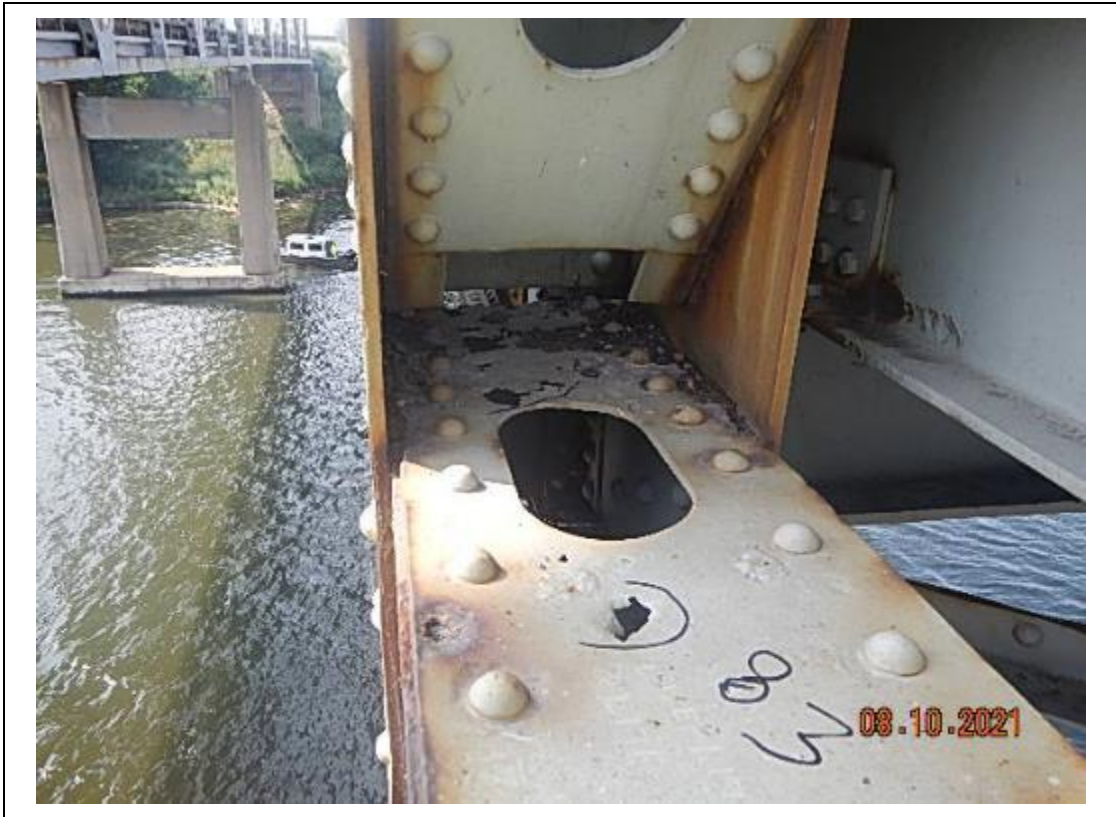
PHOTO 98

Item #	Span(s)	Member(s)	Location(s)	Photo(s)	Deficiency(ies)	Corrective Action	Year	Load Cap. Re-Eval.
81	5	L15W-L16W	4' South of L15W	98 LE	0% SL, 2" Hole in Top Plate (between access Holes)	N/A 0% SL, IRF=2.83	2009	
83	5	L16E-L17E	at L16E & L17E, Top Plate	99 LS	5% SL, (See Detail 28) at L16E 0% SL, 4" X 15" L Hole in Top Plate, at L17E	N/A 5% SL, IRF=2.83	2013	
84	5	Gusset Plate	at L17W	100 LNE	11% SL(See Detail 29) (inside) 20% SL(See Detail 30) outside	Repair 7% SL, 12% SL IRF=3.58	2009	X
85	5	Floorbeam 17	West end	101 LNW	25% Bottom Flange, 14% SL Web (See Detail 46)	N/A 14% SL Web, 25% SL Flange, IRF=1.829	2011/ 2013	
154	5	L17E-L16'E	at L17E	102 LN	0% SL, 4" Hole in Top Plate (between access Holes)	N/A	2019	
142	5	L17W-L16'W	2' from L17W	103 LN	0% SL, 2" Hole in bottom Plate (between access Holes)	N/A	2017	
86	5	Stringer 9	at Floorbeam 16', Panel 17'	104 LSE	13% SL Web (See Detail 31)	N/A No Live Load 2013	2011/ 2013

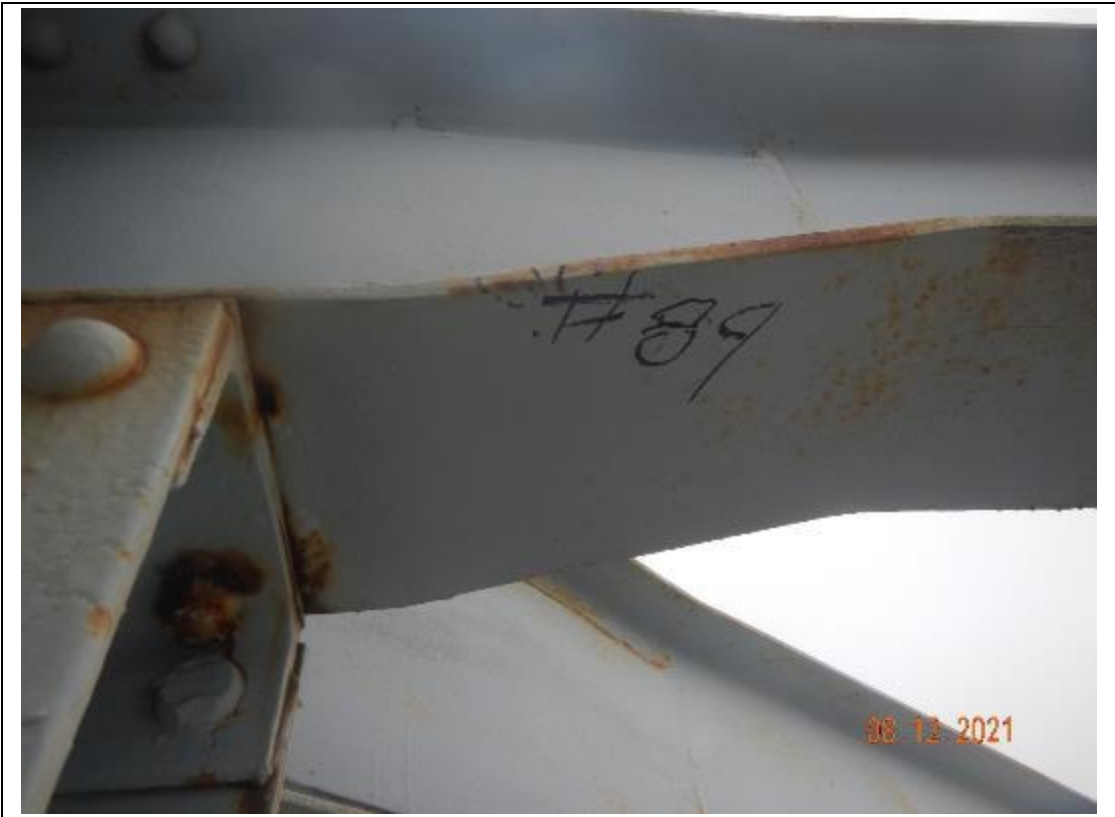
PHOTO 106

87	5	Gusset Plate	L16'E (outside)	105 LW	16" X 1/2" offset due to Pack Rust	N/A	2009	
88	5	L16'E-L15'E	at L16'E	106 LW	4% SL (See Detail 32)	N/A 4% SL, IRF=2.83	2011/ 2013	
89	5	U16'E-U16'W	at U16'E	107 LS	2- 1/4" Deep cuts into side Bottom Flange	N/A	2011	
143	5	L16'E-L15'E	2' from L15'E	108 LS	0% SL, 1" Holes in Top & bottom Plate (between access holes)	N/A	2017	
144	5	L16'E-L15'W	Last 4' from L15'W	109 LW	30% SL in angles, 2" Hole, 15% SL in bottom connection Plate, 1" Hole	N/A	2017	
90	5	Gusset Plate	L15'W (outside)	110 LN	9% SL, (See Detail 33)	N/A	2009	
91	5	Gusset Plate	L15'W (inside)	111 LN	10% SL, (See Detail 34)	N/A	2009	
92	5	Gusset Plate	L15'E (inside)	112 LE	10% SL, (See Detail 35)	N/A	2009

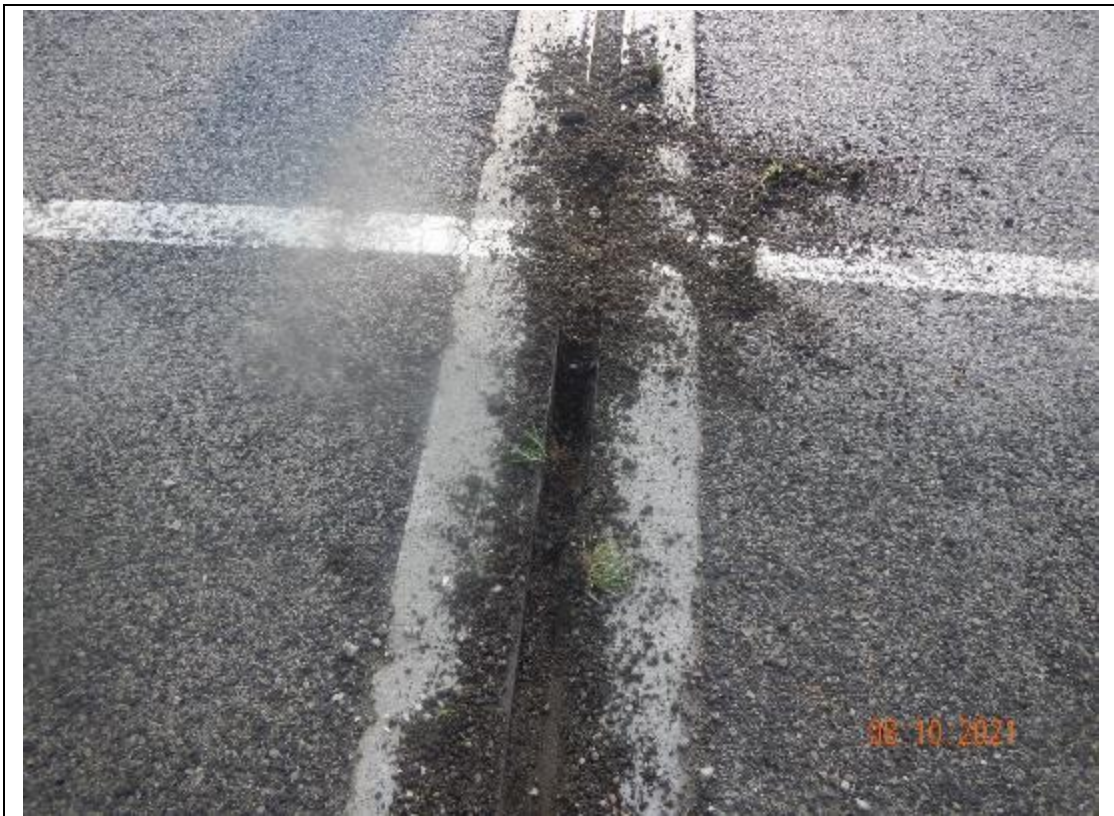
PHOTO 113

Item #	Span(s)	Member(s)	Location(s)	Photo(s)	Deficiency(ies)	Corrective Action	Year	Load Cap. Re-Eval.
145	5	L15'W-U15'W	2' & 5' above Deck	113 LSW	5" X ½" offsets (each location)	N/A	2017	
146	5	Joint	Panel Point 15', West lane	114 LE	6' failed on West side 3' failed on East side	Repair	2017	
147	5	L15'E-L14'W	at L15'E	115 LW	10%SL, 1" Hole in bottom connection Plate	N/A	2017	
93	5	U15'W-U14'E	at U14'E	116 LS	3- ¼" Cuts into side Top Flange	N/A	2011	
94	5	L15'E-L14'E	at L14'E	117 LSW	6%SL (See Detail 36)	N/A 6 %SL, IRF=4.56	2011/ 2013	
95	5	L14'E-L13'E	at L14'E	118 LW	6%SL (See Detail 36)	N/A 6 %SL, IRF=4.56	2011/ 2013	
148	5	Lateral Brace	L14'E – mid Floorbeam13' at L14'E	119 LSW	30%SL 2" Hole in horizontal angle & 1 broken Rivet	N/A	2017	
96	5	Stringer 1	at Floorbeam13', Panel 14'	120 LE	36% SL Web, (See Detail 37)	N/A No Live Load 2013	2011/ 2013	
97	5	Slide Pin	at U13'E	121 LS	3/16" grooves	N/A	2015

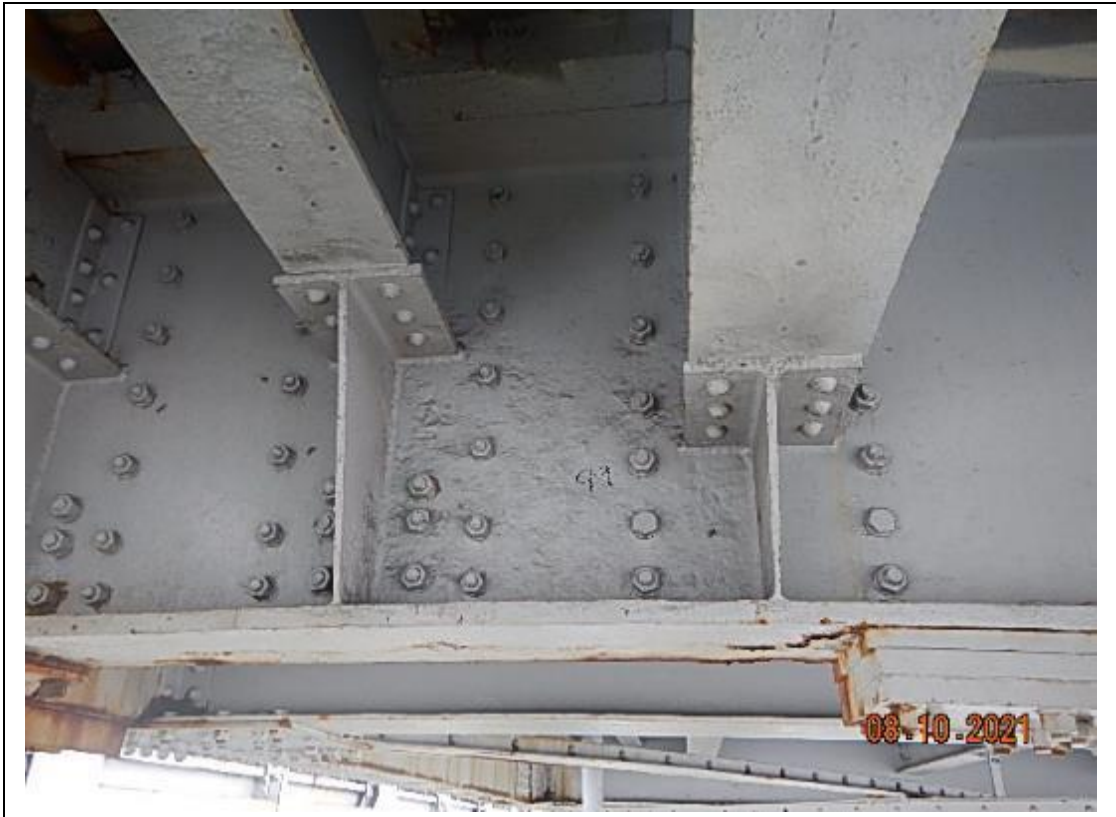
PHOTO 122

98	5	L13'E-U13'E	at L13'E	122 LW	4% SL, 10" X 1"L area of loss in Plate; 0.375" average remaining, 0.5" nominal	N/A 4 % SL, IRF=4.87	2009	
99	5	Floorbeam 13'	East end	123 LS	7% SL, Web .71" average remaining, .765" nominal	N/A 7 % SL, IRF=2.14	2013	
149	5	Joint	Panel Point 13', East & West lane	124 LN	6' failed on W side, 3' failed on E side	Repair	2017	
100	5	Stringer 1, 3-9	at Floorbeam13', Panel 13'	125 LW	0% SL, 2" X 4"L abandoned Holes (Reinforced)	N/A	2013	
101	5	Stringer 2	at Floorbeam13', Panel 13'	126 LE	0% SL, 2" X 4"L abandoned Hole (Reinforced), 2" X 4"L Hole	N/A	2013	
102	5	Gusset Plate	U13'W (outside)	127 LSW	2-plug weld on plate	N/A	2009	
103	5	Gusset Plate	U13'W (inside)	128 LSE	2-plug weld on plate	N/A	2009	
104	5	L13'W-U13'W	U13'W 18" below pin centerline	129 LW	0% SL, ½" X 2"L Torch cut, ¼" X 1"L Torch cuts on bottom fill Plate	N/A 0 % SL, IRF=5.07	2009

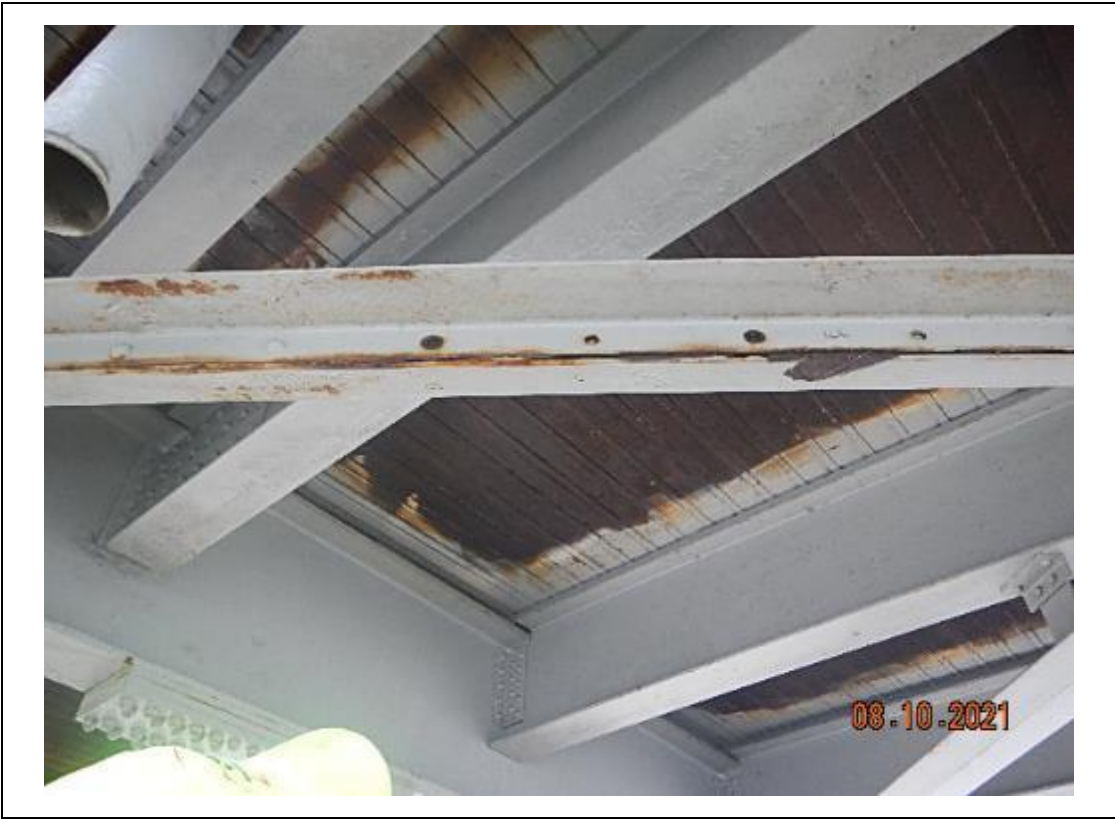
PHOTO 130

Item #	Span(s)	Member(s)	Location(s)	Photo(s)	Deficiency(ies)	Corrective Action	Year	Load Cap. Re-Eval.
105	5	L13'W-U13'W	L13'W 18" above pin Centerline	130 LE	0% SL, ½" X 2"L & ½" X 3"L Torch cuts on top fill Plate	N/A 0 % SL, IRF=5.07	2009	
106	5	Lateral Brace	Midstrut to L12'E, 10' from L12'E	131 LS	5 Broken Rivets	Repair	2013	X
108	5	Gusset Plate	L12'W (inside)	132 LE	3% SL (See Detail 39)	N/A 3% SL, IRF=1.46	2009	
109	5	Floorbeam 12'	West end	133 LN	7% SL Web .675" average remaining Web .725" nominal	N/A 7 % SL, IRF=2.01	2011/ 2013	
107	5	Stringer 9	at Floorbeam 12', Panel 12'	134 LN	14% SL Web (See Detail 38)	N/A No Live Load 2013	2011/ 2013	
110	5	L12'W-L11'W	at L12'W	135 LN	5% SL .64" average remaining in Webs, 0.700" nominal	N/A 5 % SL, IRF=2.63	2011/ 2013	
111	5	Stringer 2	at Floorbeam 11' Panel 12'	136 LS	6% SL, Web 14" Cope .37 average remaining, .39" nominal	N/A 6% SL, IRF=2.80	2013

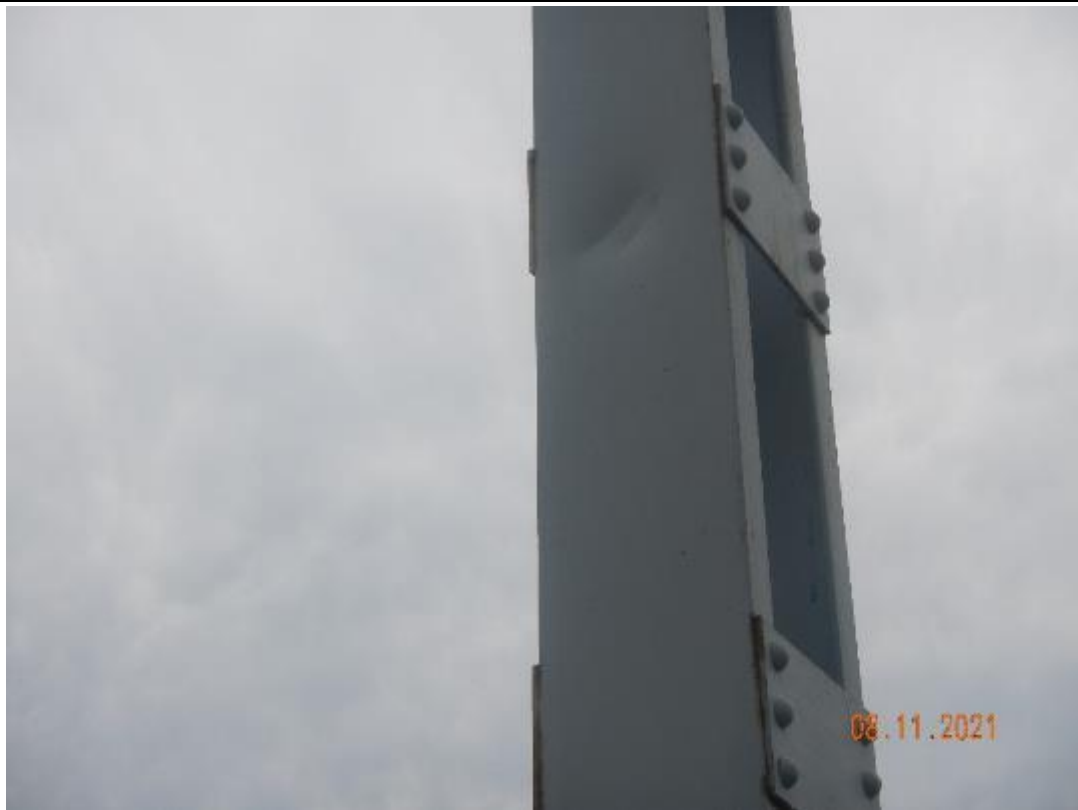
PHOTO 145

Item #	Span(s)	Member(s)	Location(s)	Photo(s)	Deficiency(ies)	Corrective Action	Year	Load Cap. Re-Eval.
120	6	Stringer 1	Midspan, Panel 8'	145 LSW	16% SL Bottom Flange (See Detail 41)	N/A No Live Load 2013	2011/ 2013	
121	6	L7'W-U7'W	mid height	146 LW	8" X 5/8" offset & 6" X 3/8" offset	N/A	2009	
122	6	Stringer 2 – 9	at Floorbeam 6'	147 LW	0% SL, 2 - 7/8" misdrilled Holes in Stringer Web repair Plate	N/A	2015	
150	6	Joint	Panel Point 6', West lane	148 LE	15' failed on West side	Repair	2017	X
123	6	U5'E-U4'E	U5'E	149 LNE	Fully crack tack weld between inside gusset plate and upper chord	N/A Crack relieved	2009	
124	6	Gusset Plate	L4'W (inside)	150 LNE	4% SL, (See Detail 42)	N/A	2009	
125	6	Floorbeam 4'	each end	151 LS	3% SL, Web .702 average remaining, .725 nominal (East) 5% SL Web .691" average remaining, .725 nominal (West)	N/A 5 % SL, IRF=2.06	2013	
126	6	Stringer 7	Panel 4' full length	152 LSW	8% SL Top Flange, 6% SL Web, 19% Bottom Flange (See Detail 43)	N/A 8% SL Top Flange, 6% SL Web, 19% Bottom Flange, IRF=1.47	2011/ 2013

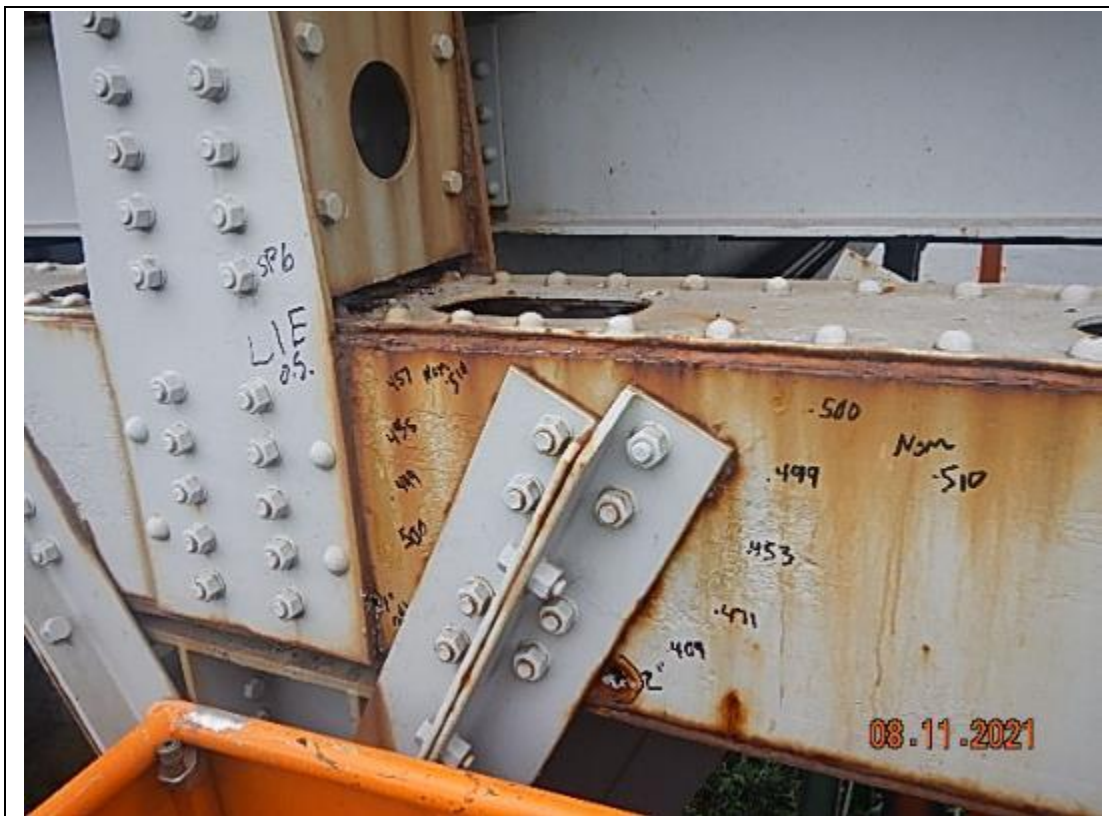
PHOTO 158

Item #	Span(s)	Member(s)	Location(s)	Photo(s)	Deficiency(ies)	Corrective Action	Year	Load Cap. Re-Eval.
159	6	L1'E-L2'E	at L1' E	158 LSW 159 LSW	12% SL Lower Chord East side channel web with 1" and 2" holes. 2-4" holes in top of bottom chord, holes in line with access holes (See Detail 1)	Repair	2021	X
156	6	L1'E-L0'E	at L0'E	160 LS	22% SL in East Channel web, .399" average remaining in both Webs, .45" nominal (Detail 51)	N/A	2019	X
132	6	Floorbeam 0'	South side of Floorbeam	161 LE	14 Bracket welded to Bottom Flange	N/A	1999	
133	7	Cross Frame	at Pier 6, between Girder 5 & Girder 6	162 LS	26% SL, 3" & 1" X 2"L Hole in lower horizontal angle	N/A	2015	
134	7	Girder 1 & Girder 6	10' from Pier 6	163 LN 164 LW	Broken Bolts on temporary support 1 at G1 Flange connection 4 at G6 Flange connection, 4 Misdrilled Holes in vertical connection at G1 & G6		1999	X
151	7	Girder 3	at South Abutment	165 LSE	2" & 1½" Crack in Bottom Flange (See Detail 50)	N/A	2017

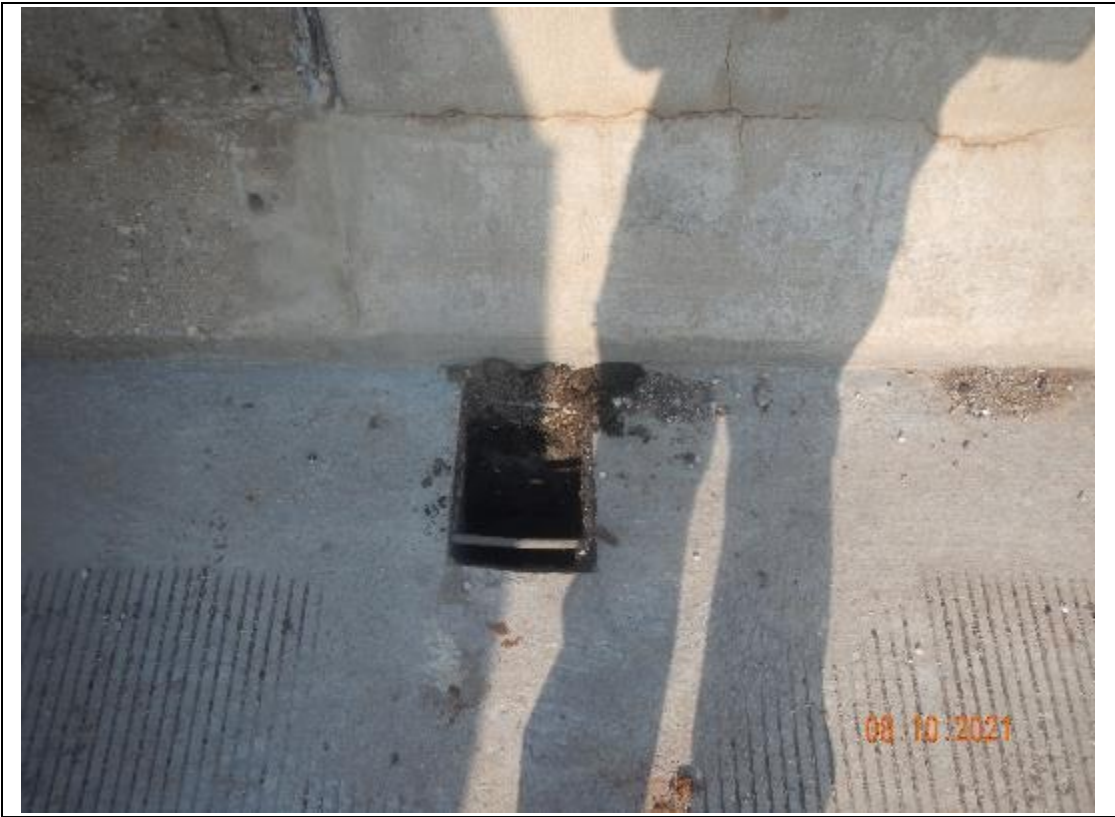
PHOTO 166

Table 1			
Span	Location	Deficiency	Photo
2	Midspan, West side	missing drain cover	166 LS
5	2' South of Floorbeam 16' East side	1" hole in drain extention	*2017 ?
7	1 ST dain South of P6, West side	missing drain cover	167 LW
